Inghams - Project Titan

Job No: 23-006

# Condition Assessment Report Project Titan

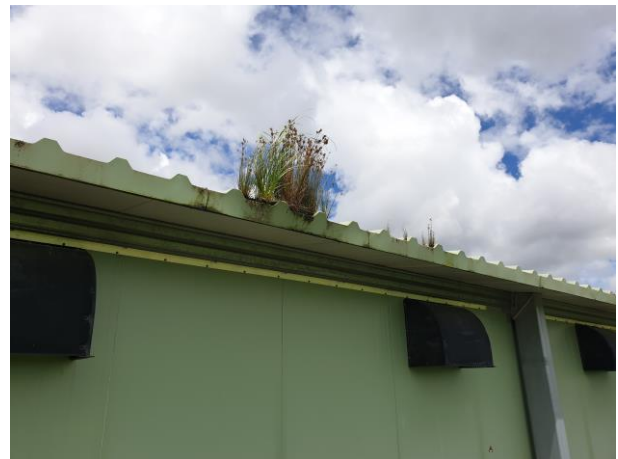
Vegetation growing in the gap between the roofing and the end cap flashing

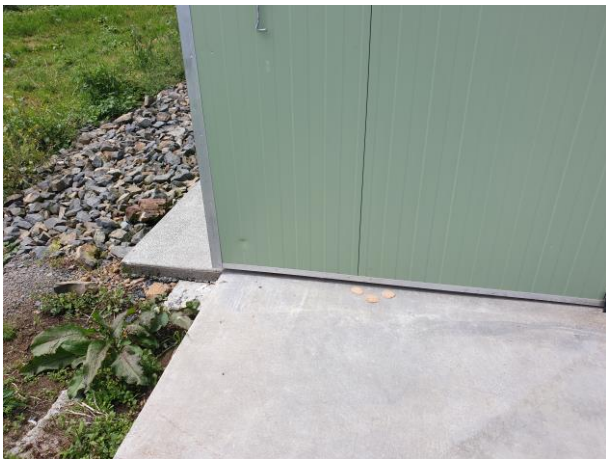
Minor wall damage

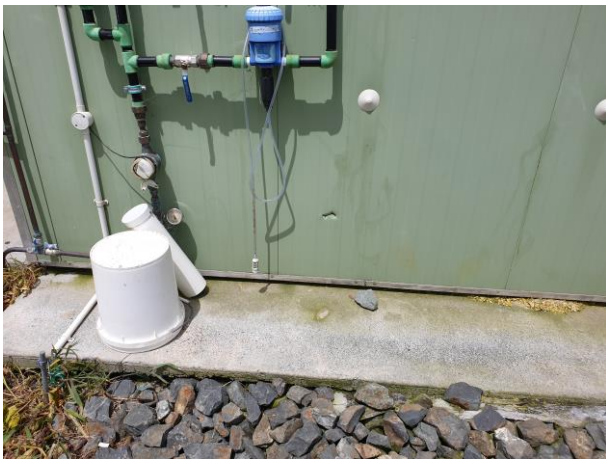
Minor wall damage

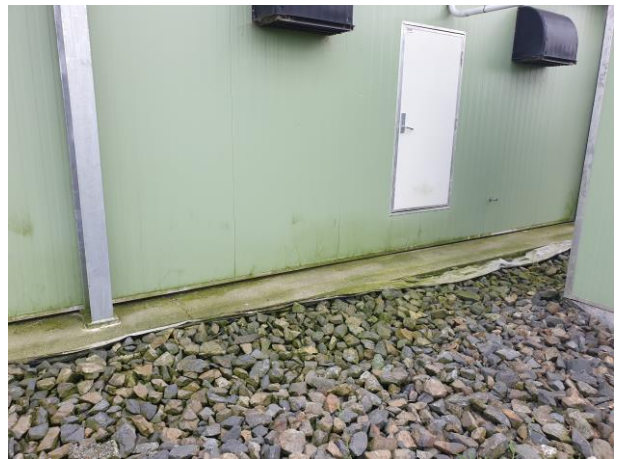
Minor perimeter slab cracking and green mould

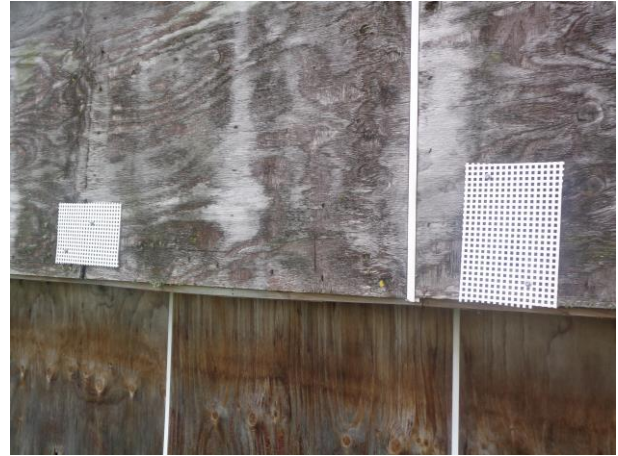
Poor repairs to holes in plywood.

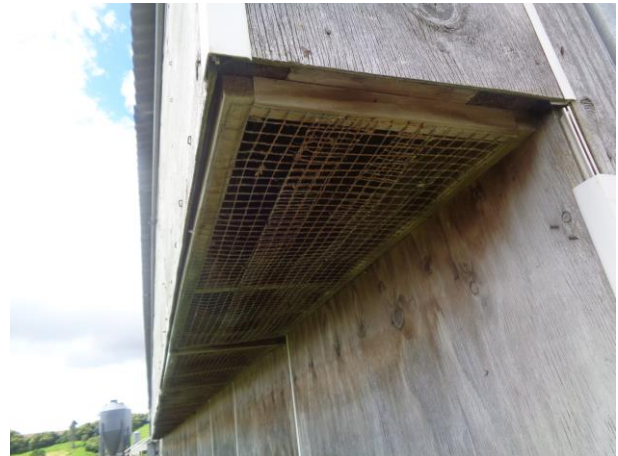
Rusting mesh vents

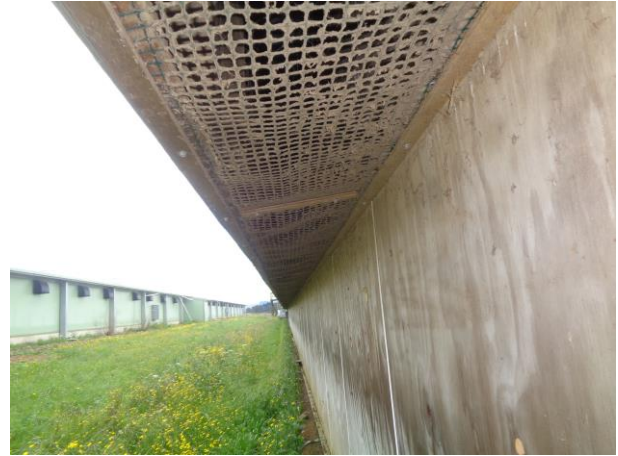
Vent mesh very dirty

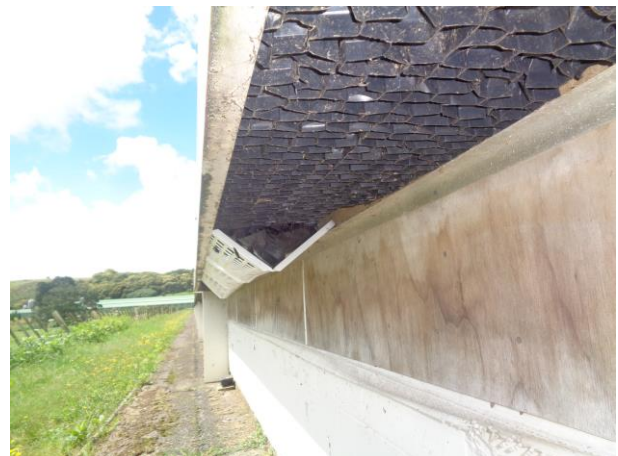
Poor repair to vent grille.

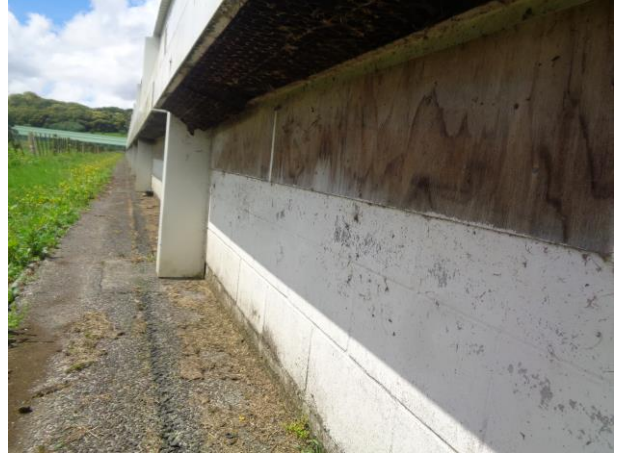
Plywood with no protective coating.

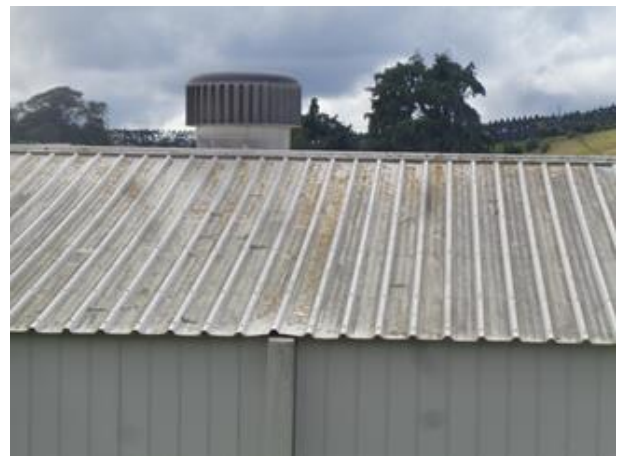
Roof has lichen and grime.

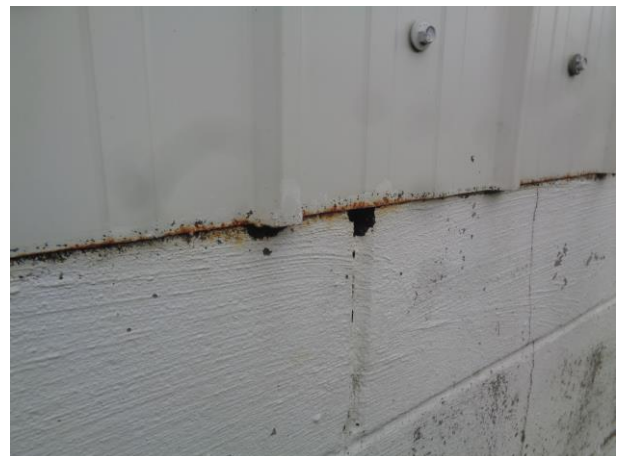
Rusting of cladding at lap with concrete

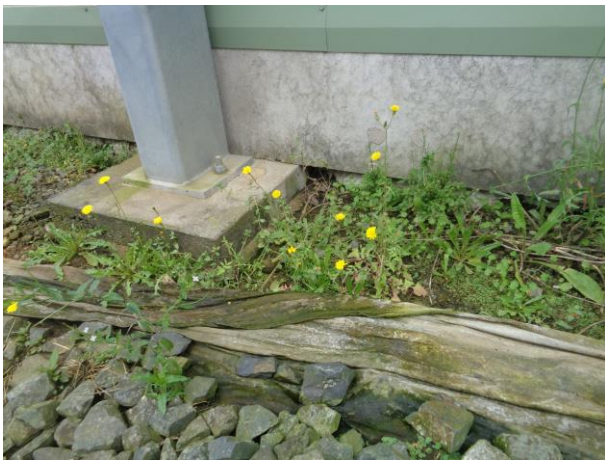
Column base plate best on plinth.

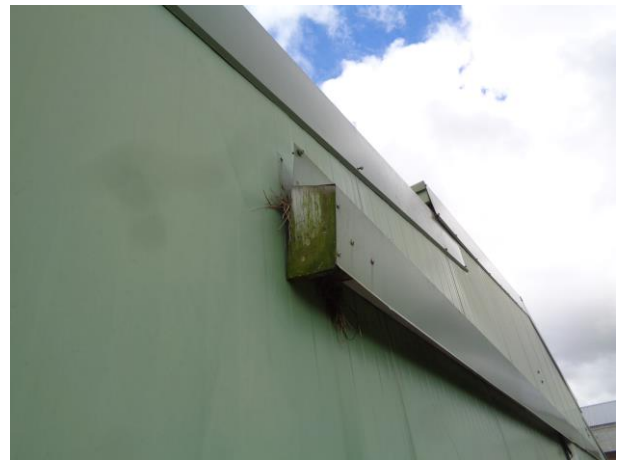
Door track flashing loose.

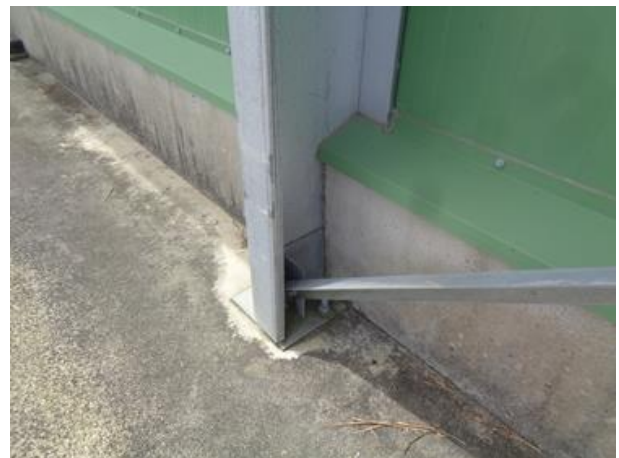
Base plate best on a concrete plinth

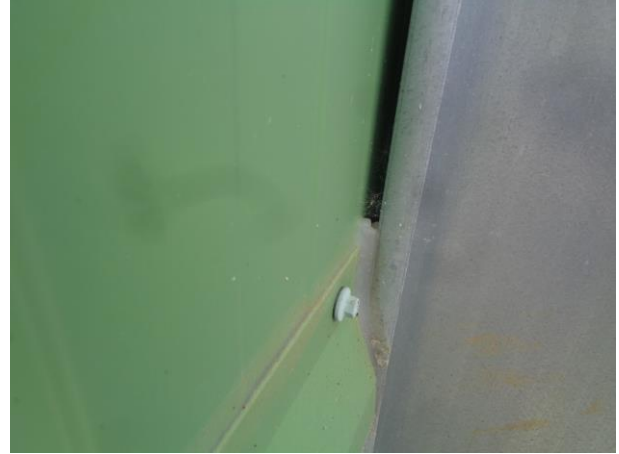
At column gap for water ingress

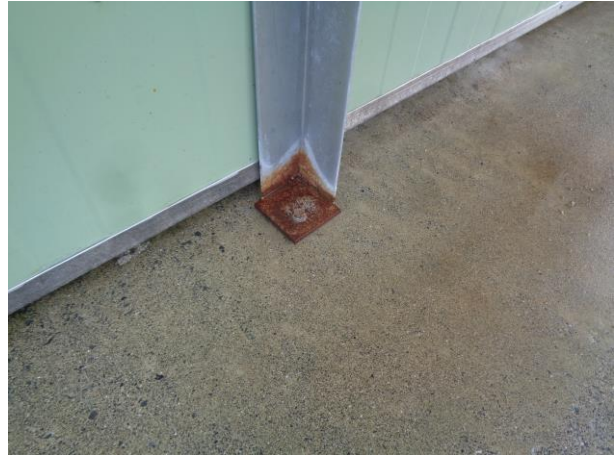
Rust to extract louvre frame support.

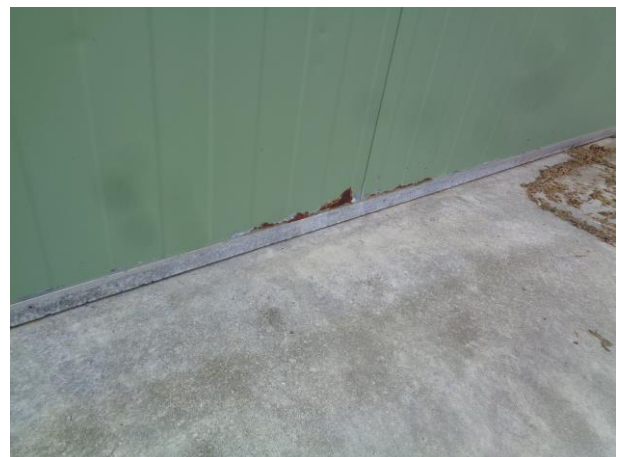
Rust to insulated panel at interface with concrete paving.

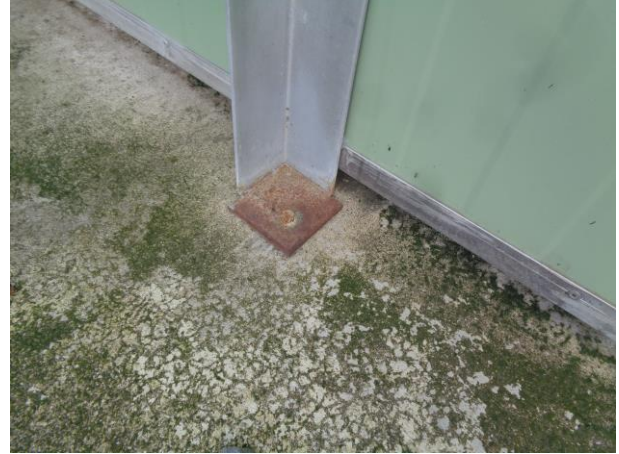
Rust to extract louvre frame

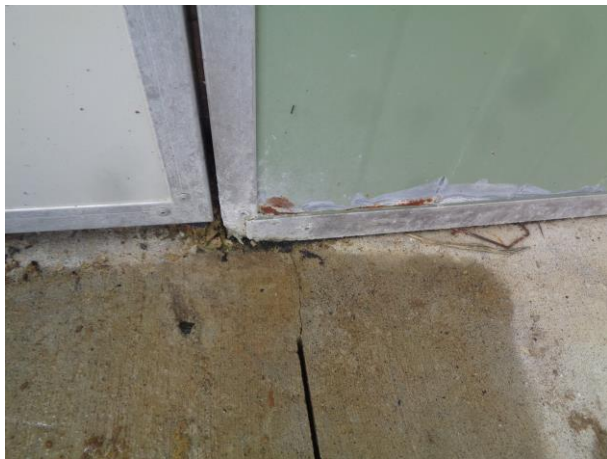
Rust to insulated panel at concrete paving.

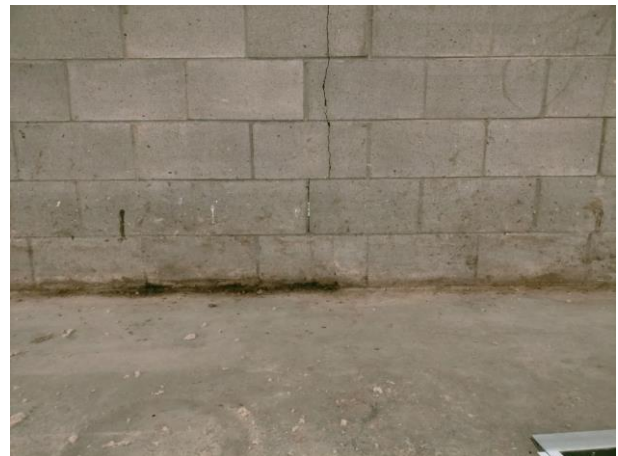
Full thickness vertical shrinkage crack in perimeter block wall

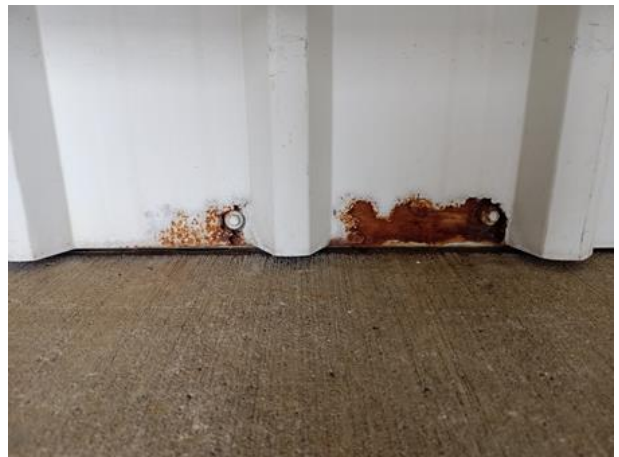
Sheet metal patches to damaged insulated panel

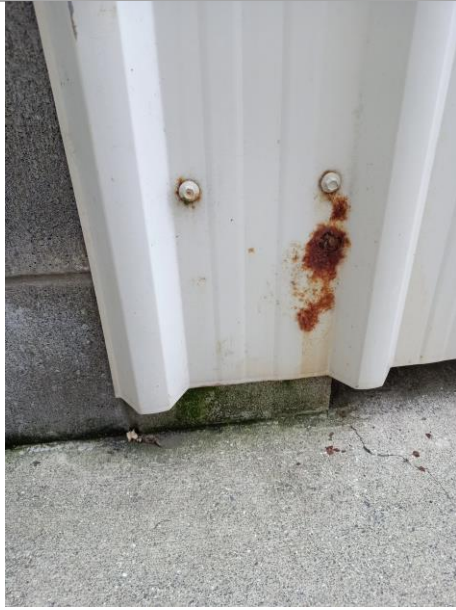
Corroded metal cladding at lap over concrete.

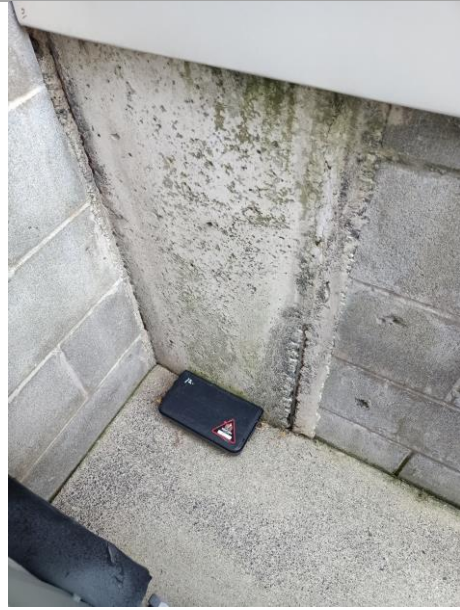
Reinforcing bar visible at insitu concrete

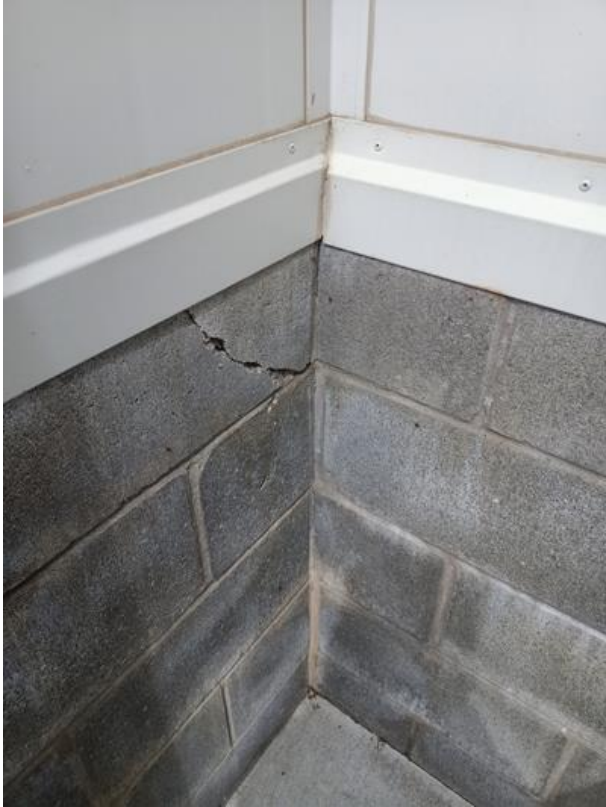
Cracked concrete block.

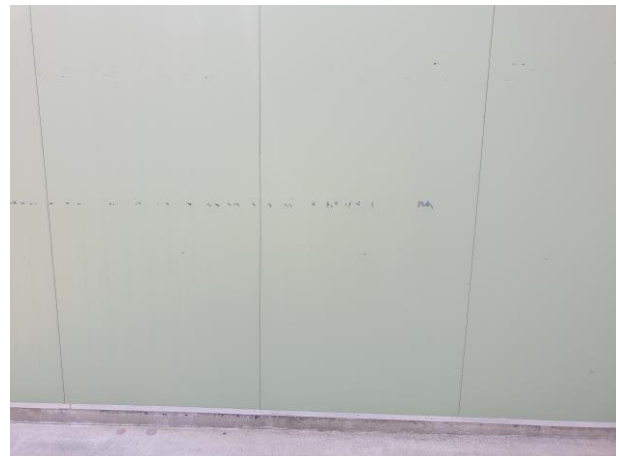
Localised areas of minor wall damage

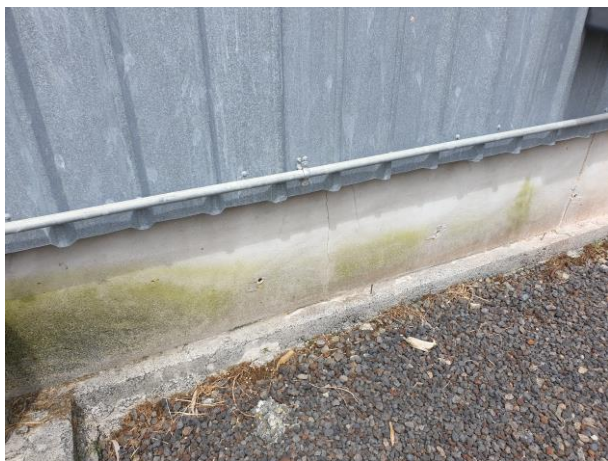
Typical perimeter upstand wall cracking and mould

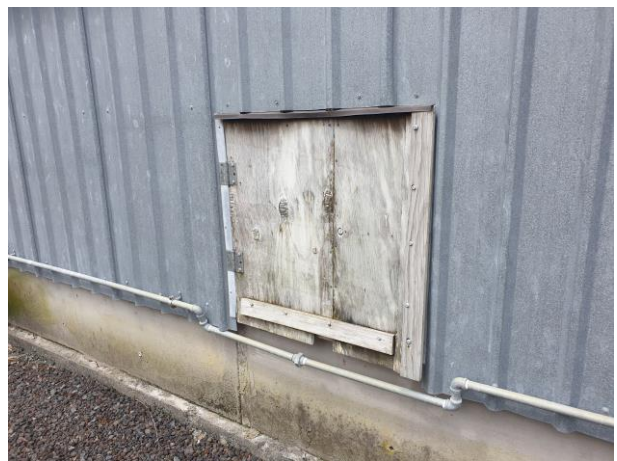
Typical weathering of doors

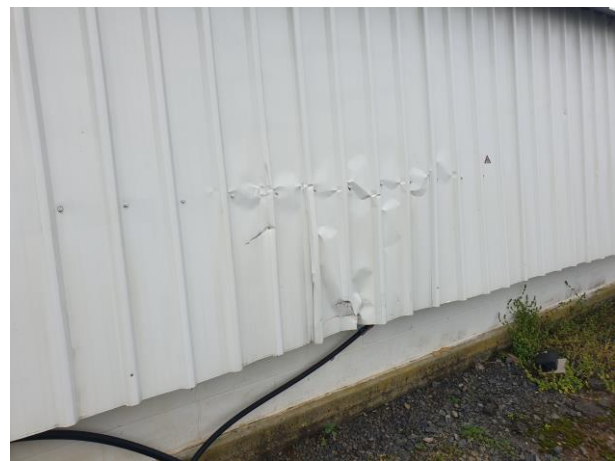
Typical perimeter upstand wall cracking and localised cladding damage

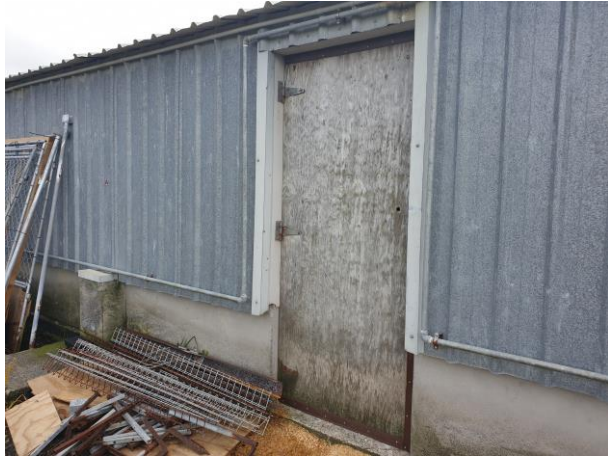
Typical weathering of doors

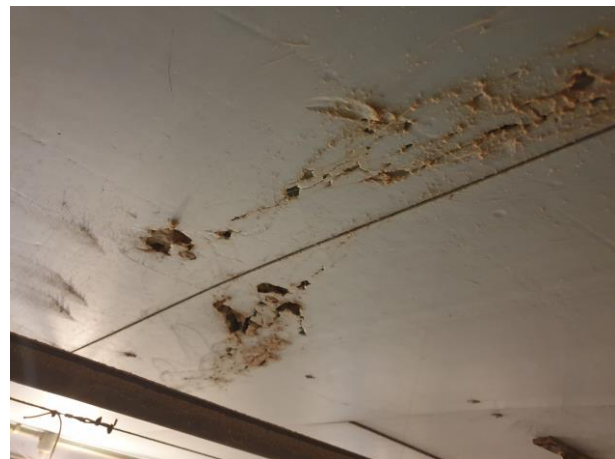
Typical ceiling lining damage

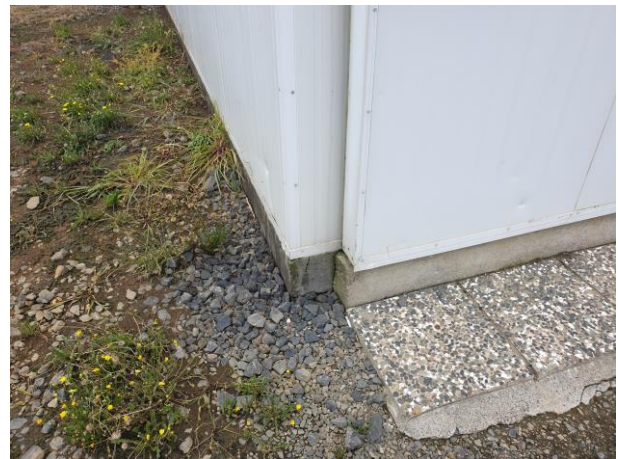
Minor slab/foundation crack
