Inghams - Project Titan

Job No: 23-006

# Condition Assessment Report Project Titan

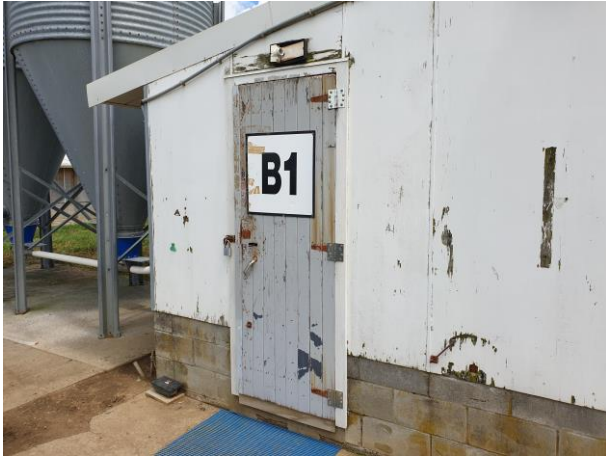
Typical weathering of exterior cladding and doors

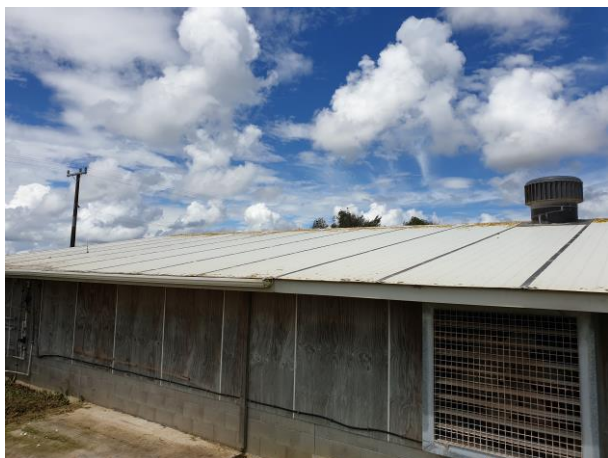
Lichen growth on roofing

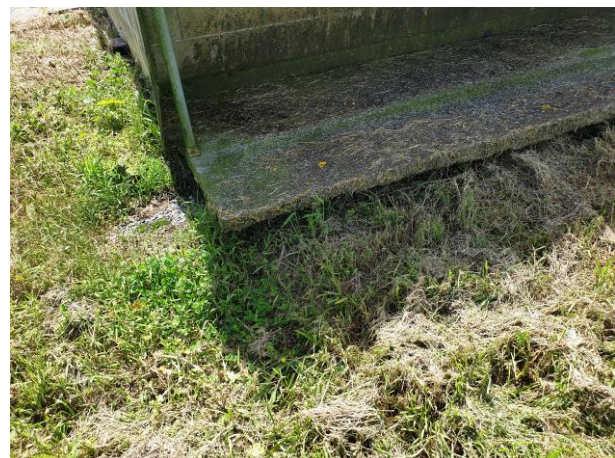
Typical partial undermining of exterior slab

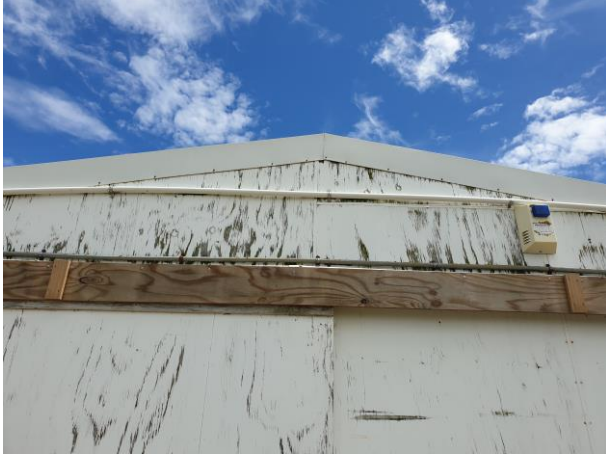
Typical weathering of exterior

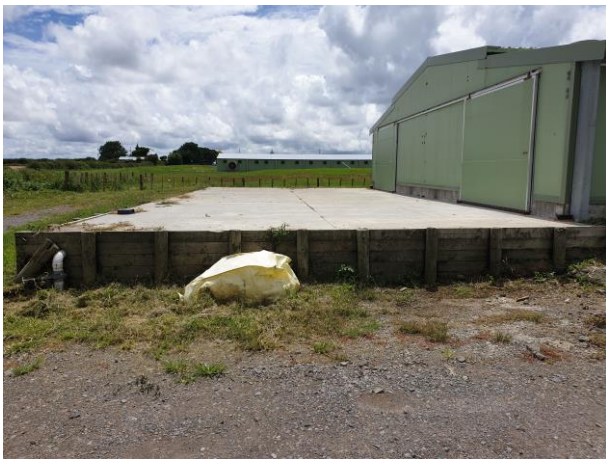
Timber pole retaining wall to rear yard slab showing minor damage to posts and rails

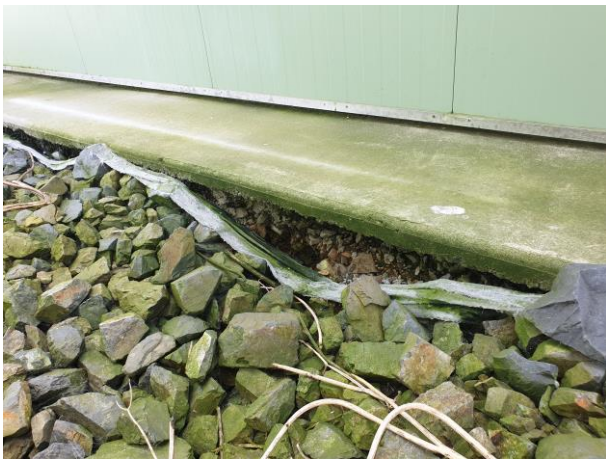
Typical undermining of perimeter slab

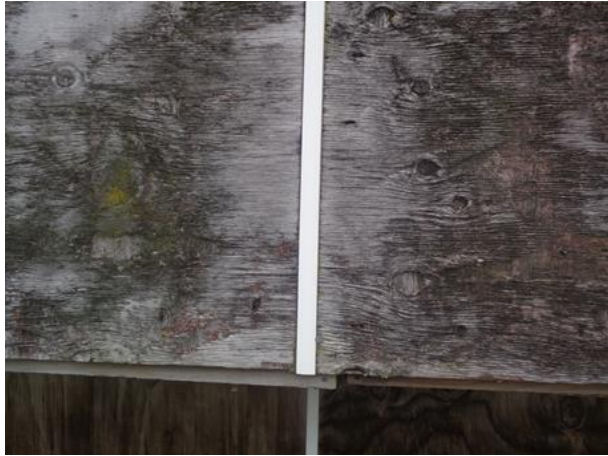
Plywood in poor condition

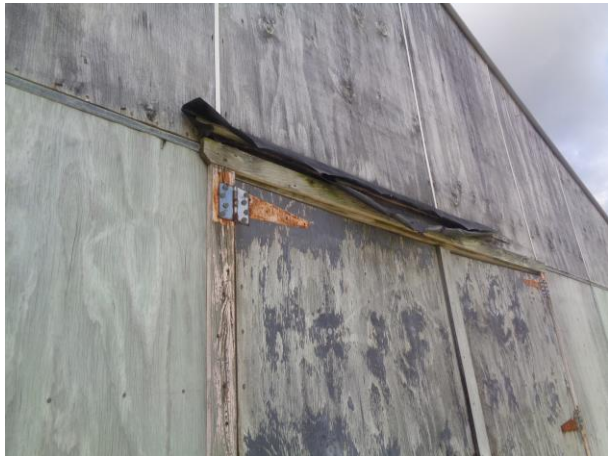
Ineffective door head flashing

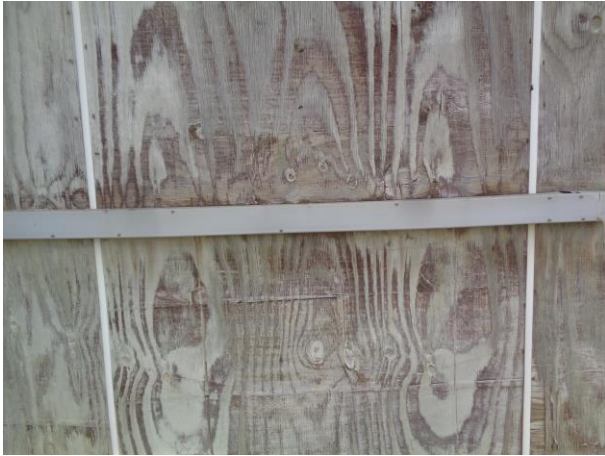
Plywood in poor condition

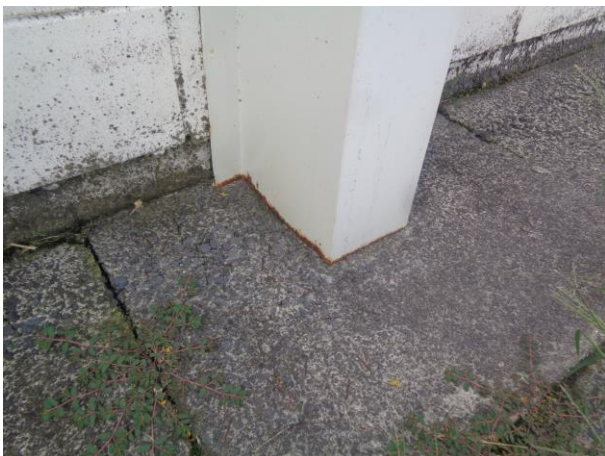
Rusting of column cover flashing.

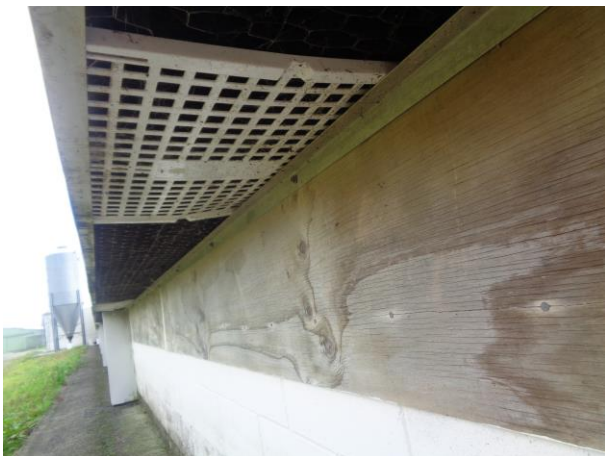
Poor repair to vent grille and plywood with no protective coating.

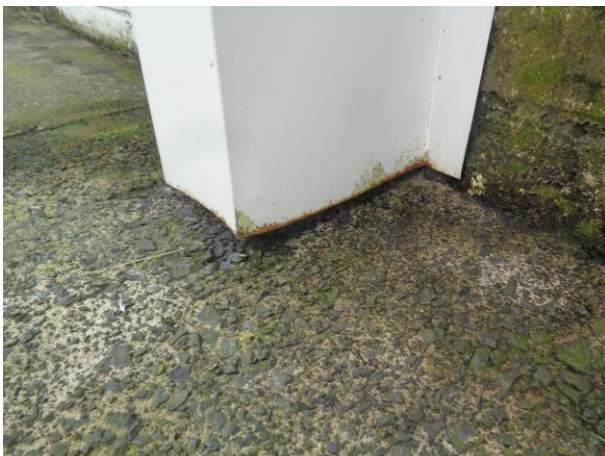
Rusting of column cover flashing.

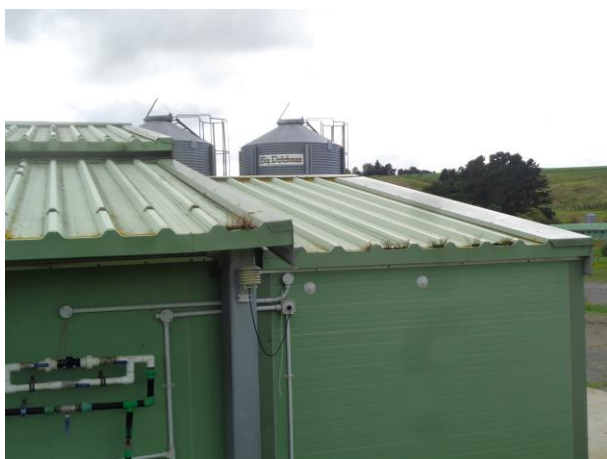
Vegetation growing at insulated panel end caps

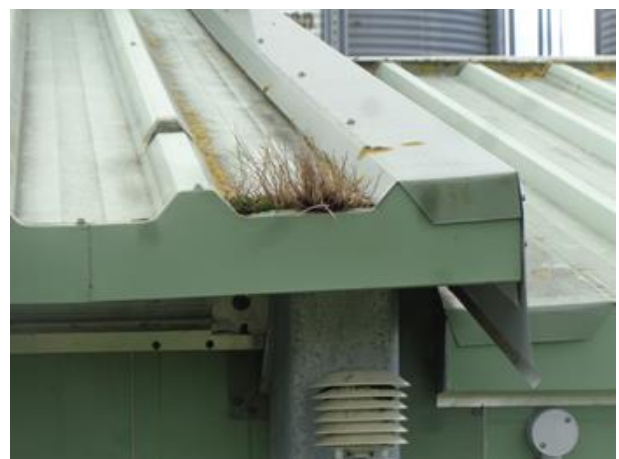
Vegetation growing at insulated panel end caps

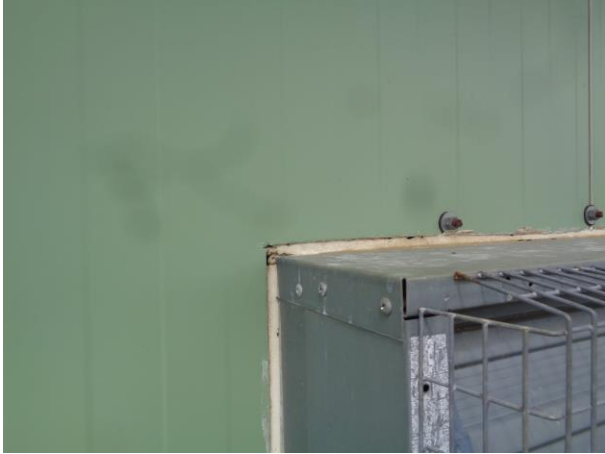
Poor installation detail around louvre frame

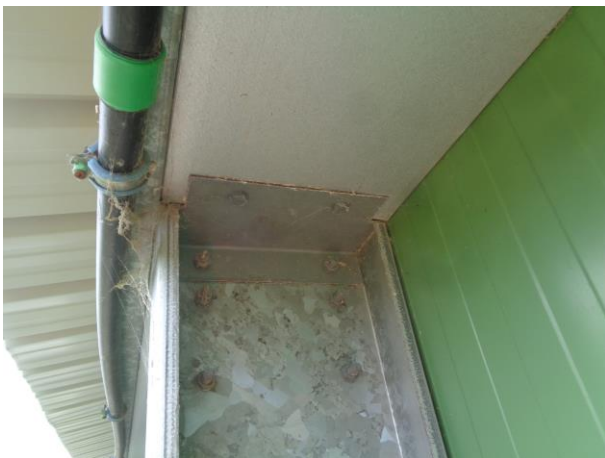
Rust developing on folded steel cleat

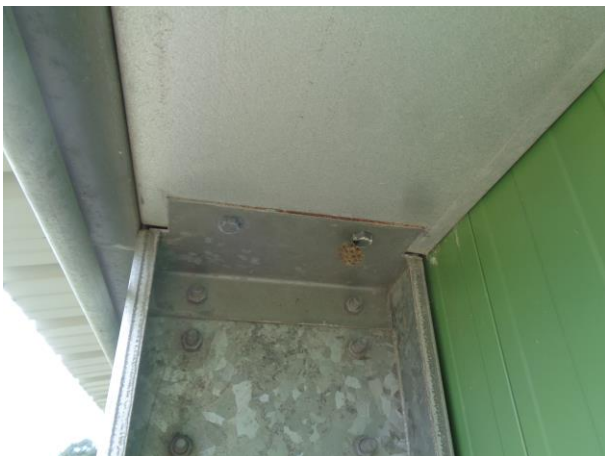
Rust developing on folded steel cleat

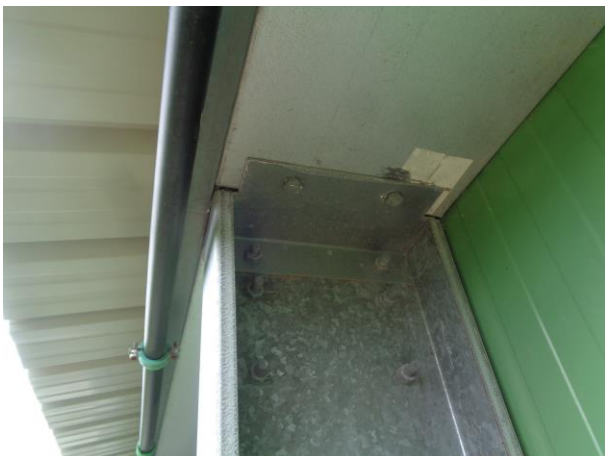
Rust developing on folded steel cleat

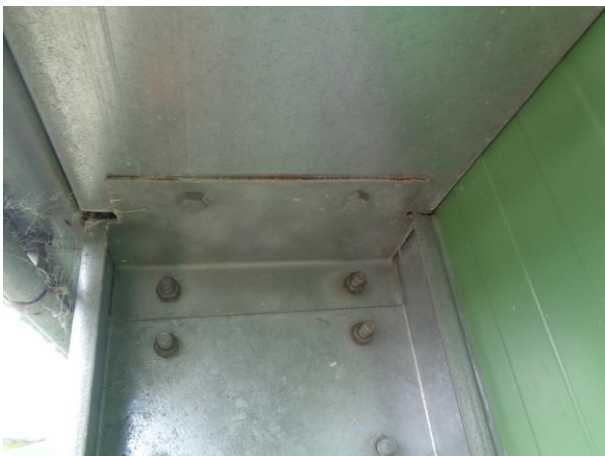
Rust developing on folded steel cleat

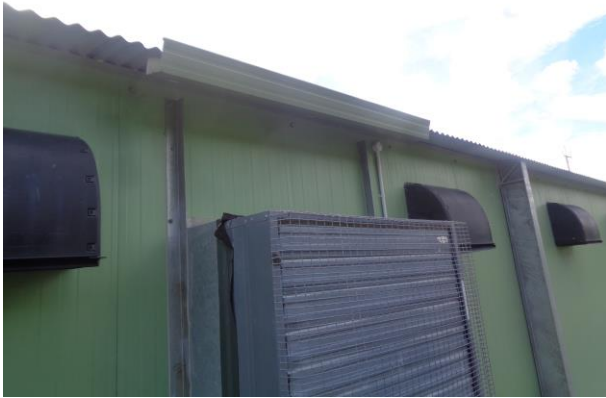
Intake ducts and extract louvres

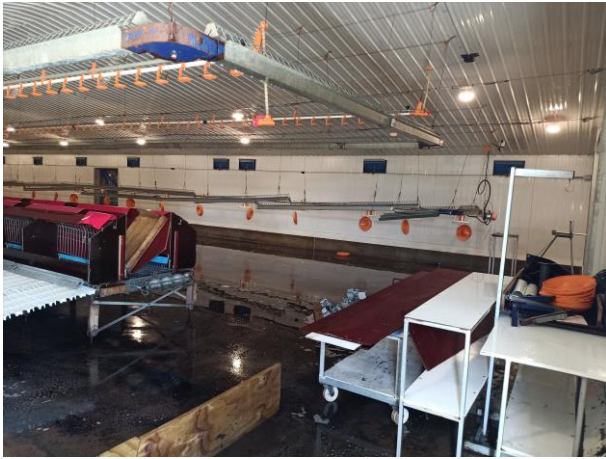
Shed empty and being cleaned.

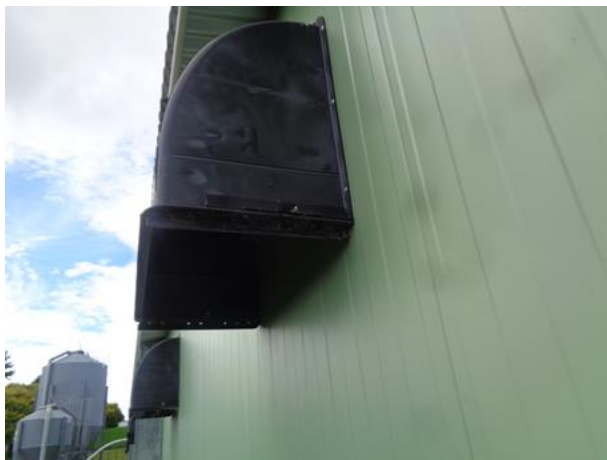
Intake ducts and extract louvres. Louvres to black intakes missing or damaged.

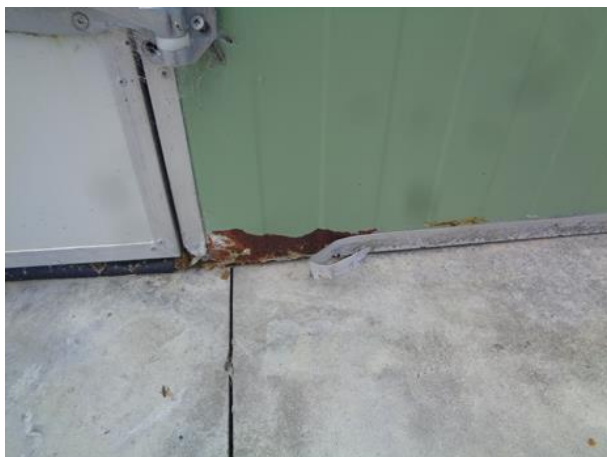
Rust to insulated panel at interface with concrete paving.

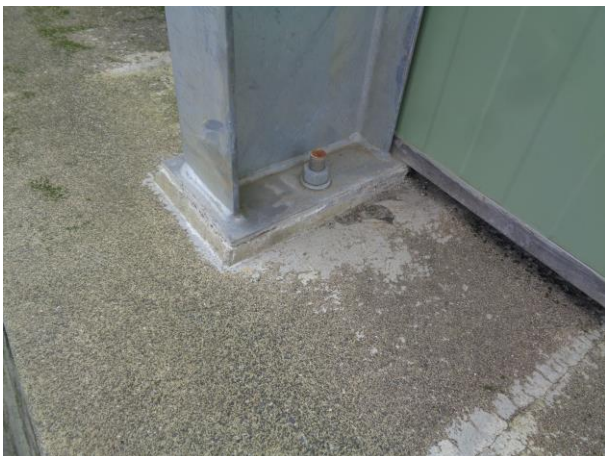
Insulated panel close to concrete slab and not located on a concrete nib.

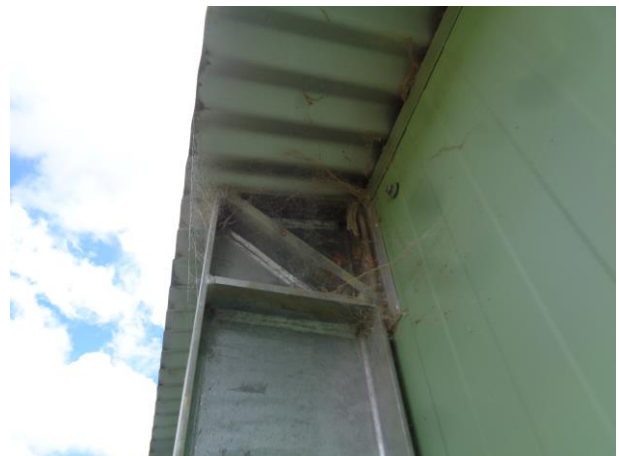
Exterior structural portal leg - galvanized steel

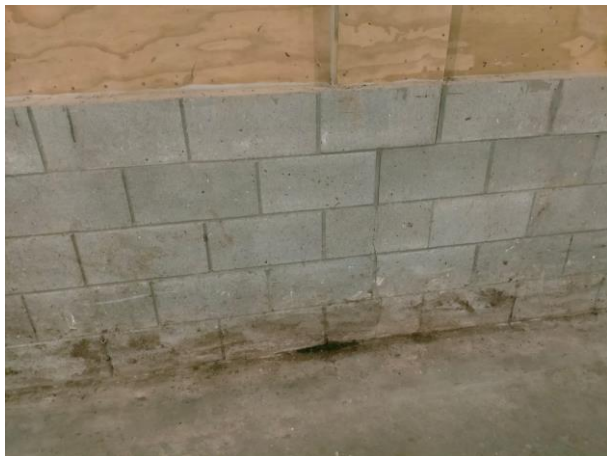
Typical vertical shrinkage cracking in perimeter block walls

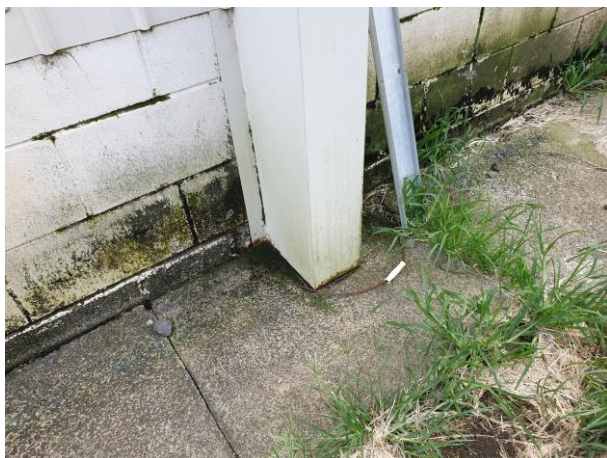
Corrosion of Colorsteel flashing around external columns

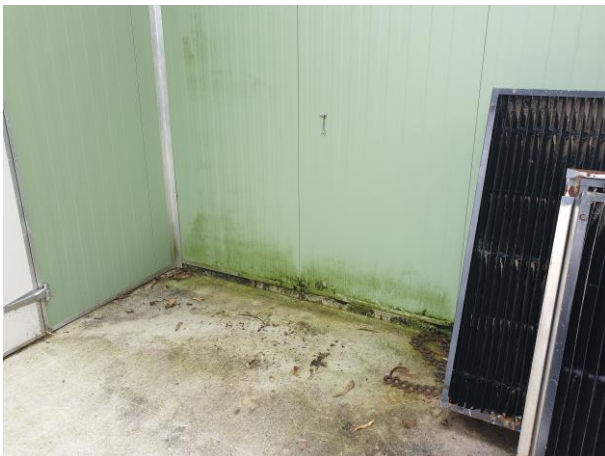
Localised areas of mould

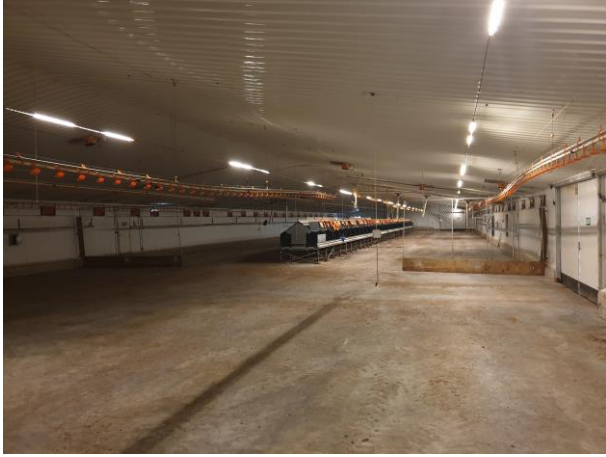
Localised areas of minor wall damage

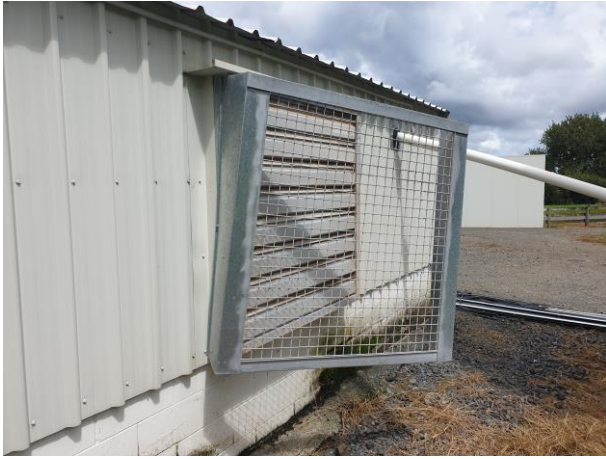
Dislodged ventilation screen

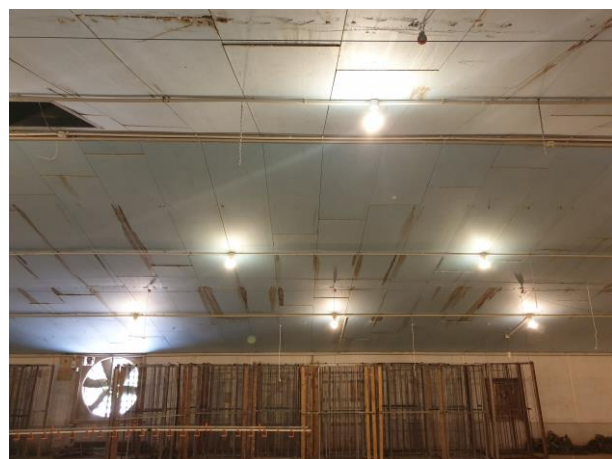
Typical interior construction  
Typical ceiling lining damage

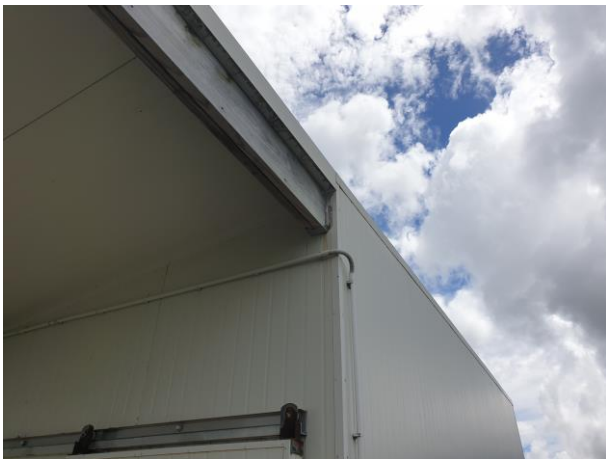
Light weathering to exposed timber beam

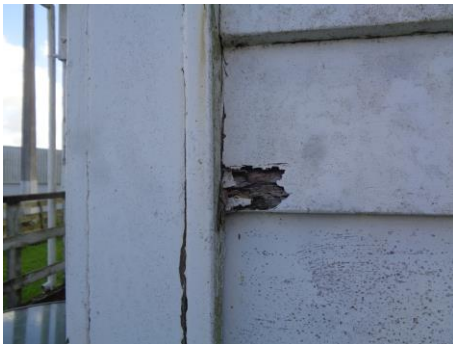
Rot to weatherboard

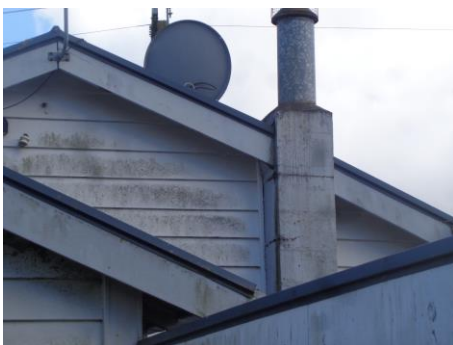
Cracks to chimney

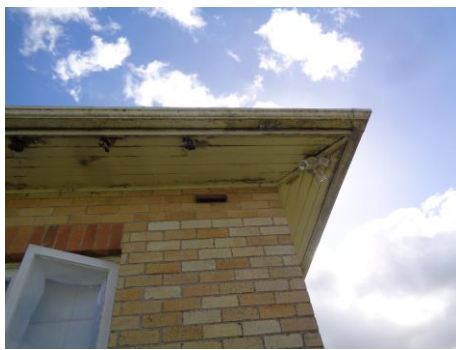
Grime to soffit and gutter

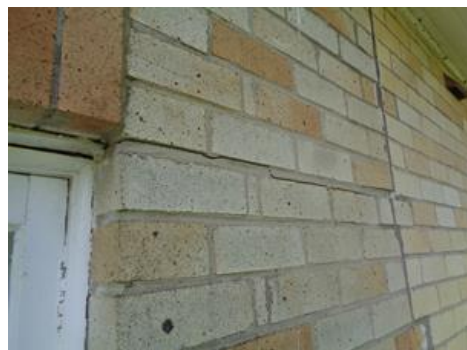
Crack to brick work of extension

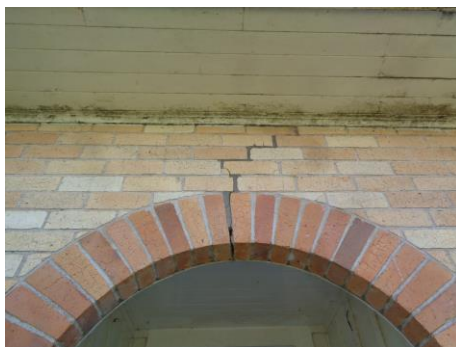
Crack to brick work at entry arch.

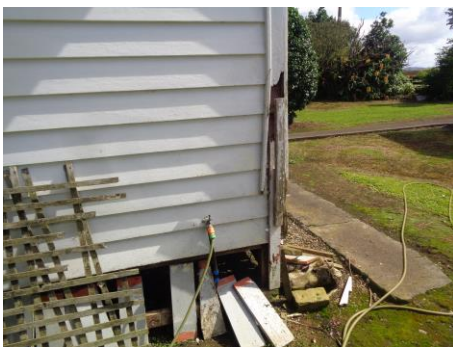
Rotten timber corner facing

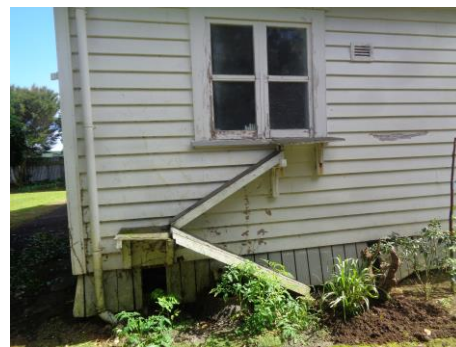
Timber window poor condition.

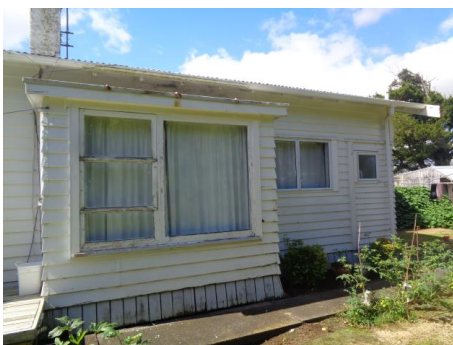
Timber window poor condition

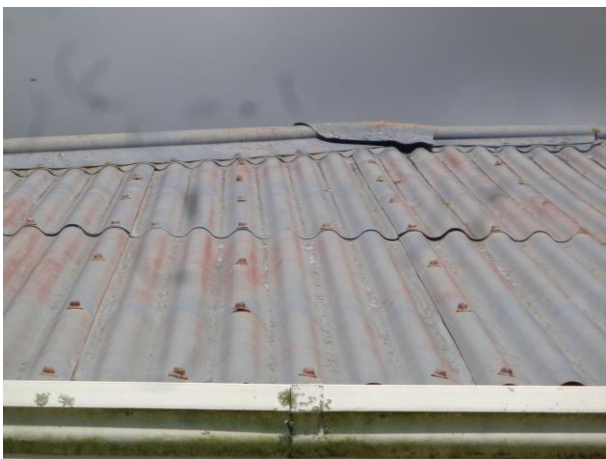
Roofing nails old lead head type – replace.

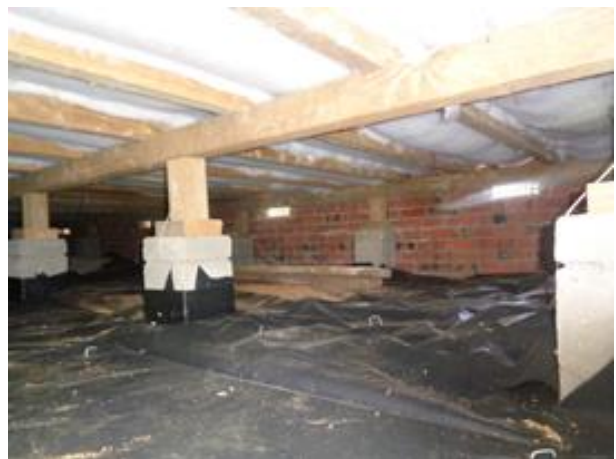
Subfloor - insulation and pvc sheet.

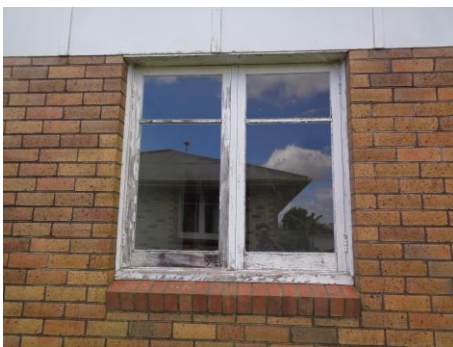
Timber joinery in poor condition.

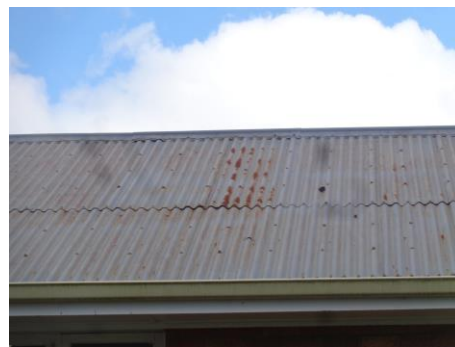
Roofing iron surface rust

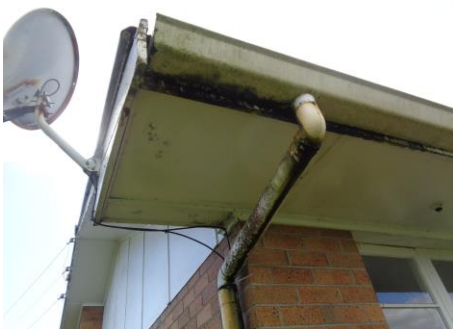
Grime to soffit, gutter and downpipe

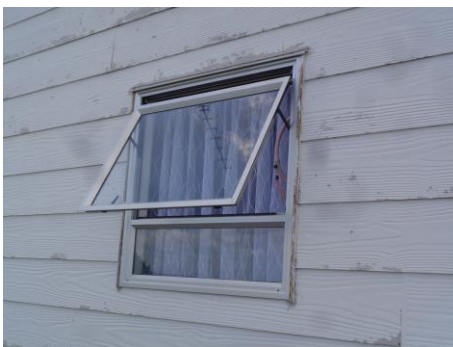
Timber scribe in poor condition

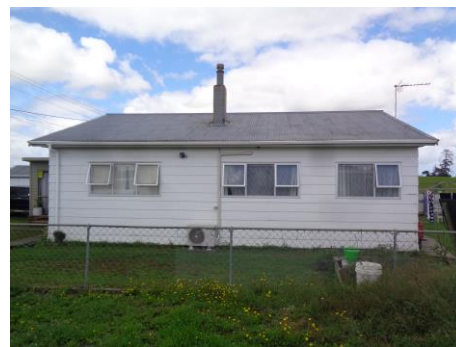
Roof showing signs of wear.

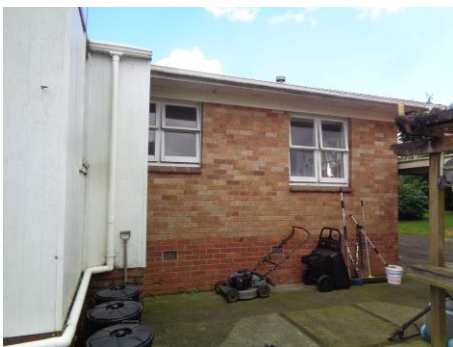
Timber joinery poor condition

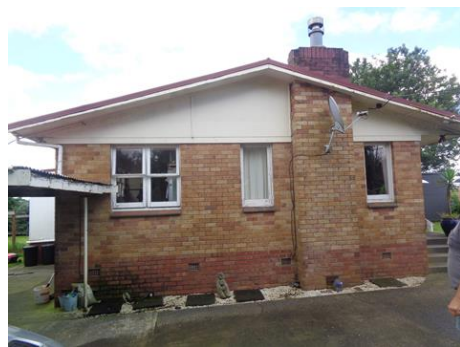
Barge board in fair condition

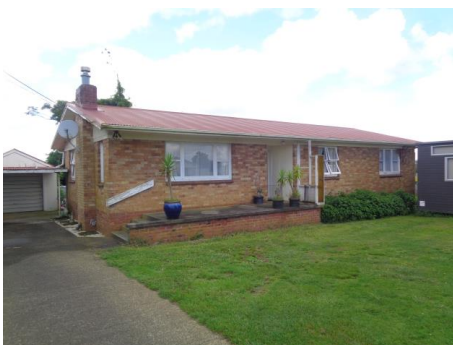
Roof in fair condition

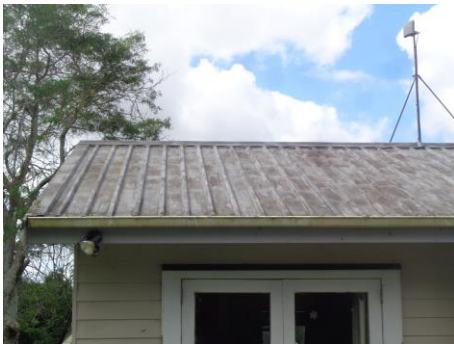
Odd appearance of roof – investigate condition

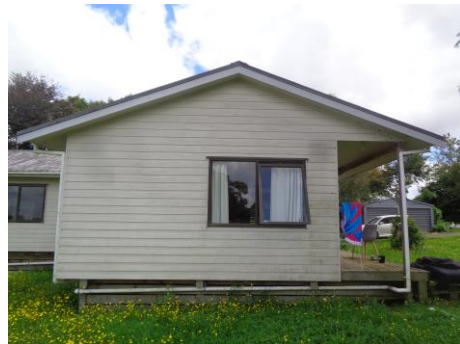
Grime to walls

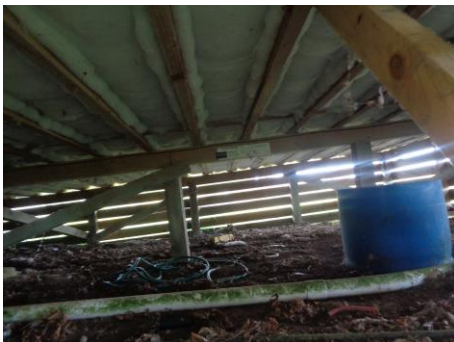
Subfloor insulation. Sheet pvc not required.
