Inghams - Project Titan

Job No: 23-006

# Condition Assessment Report Project Titan

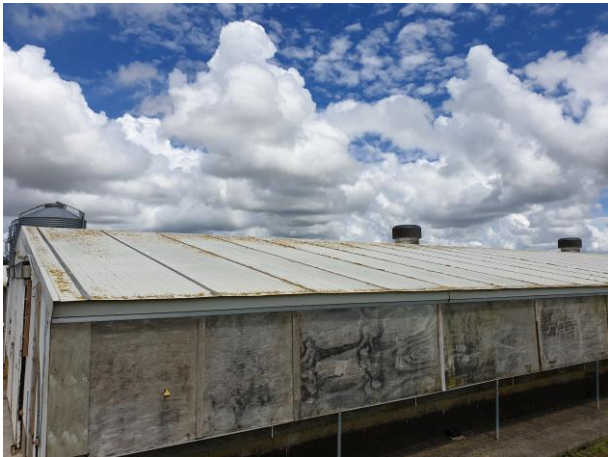
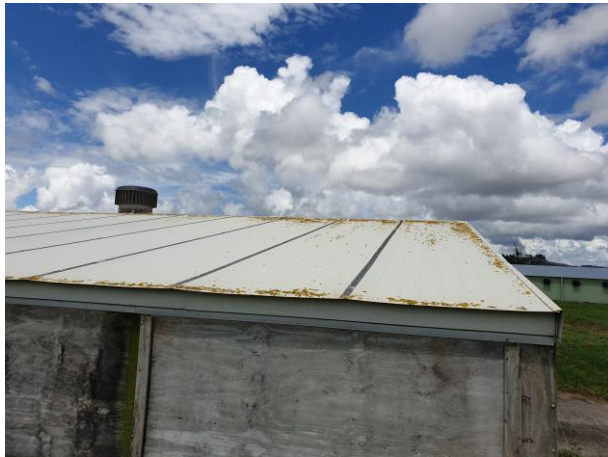
Lichen growth on roofing

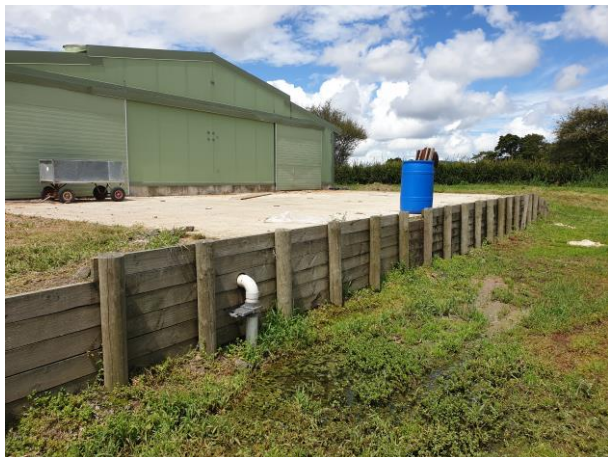
Timber pole retaining wall to rear yard slab showing minor damage to posts and rails

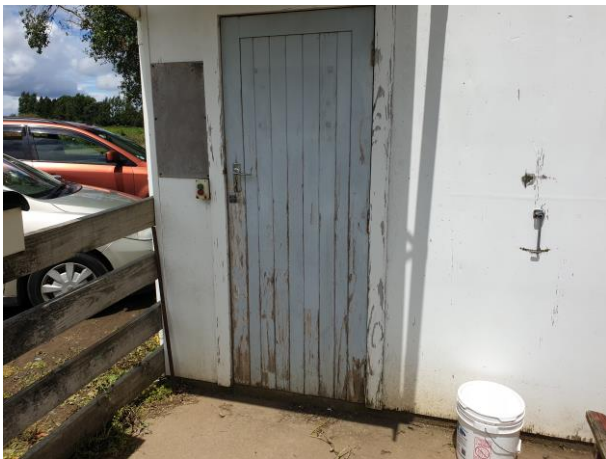
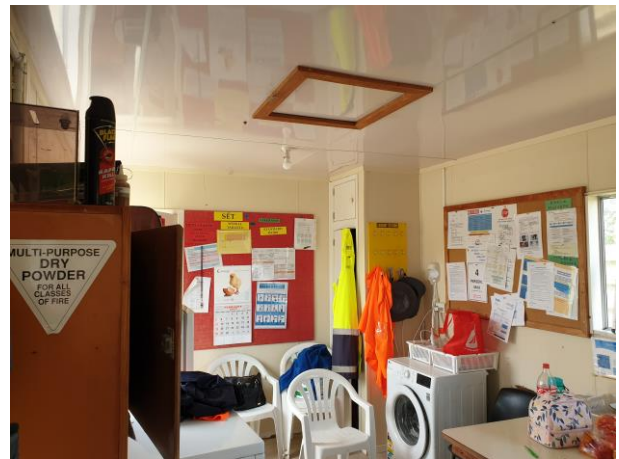
Typical weathering of joinery and cladding

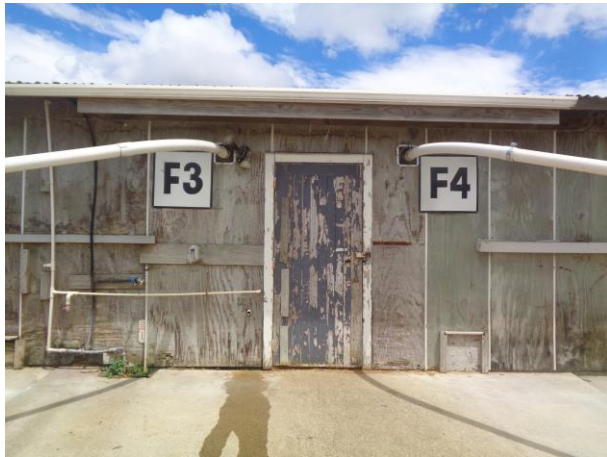
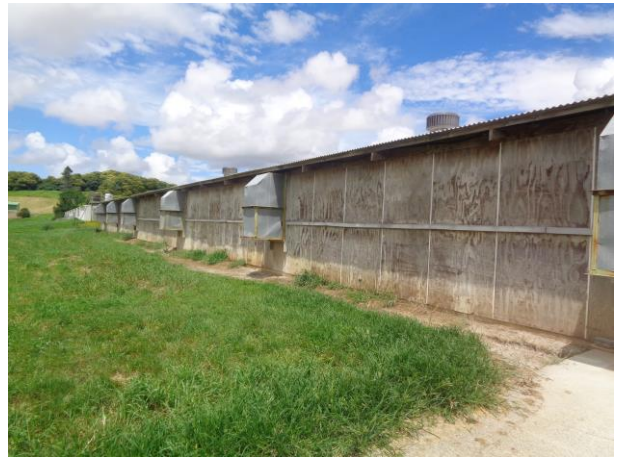
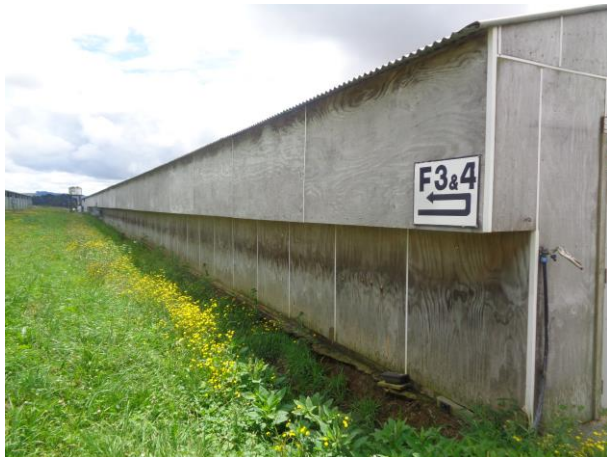
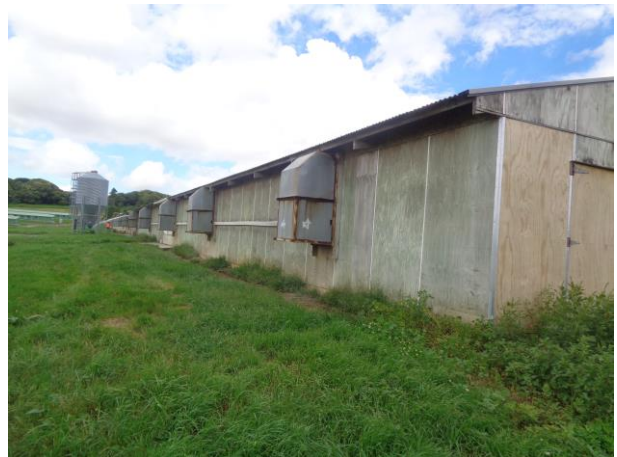
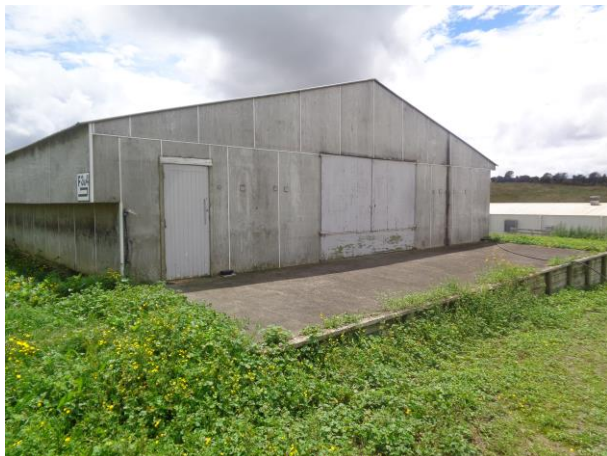
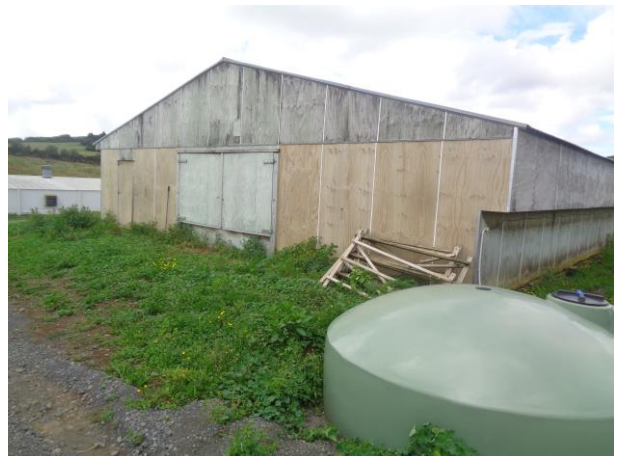
Shed F3 & F4

Typical exterior view

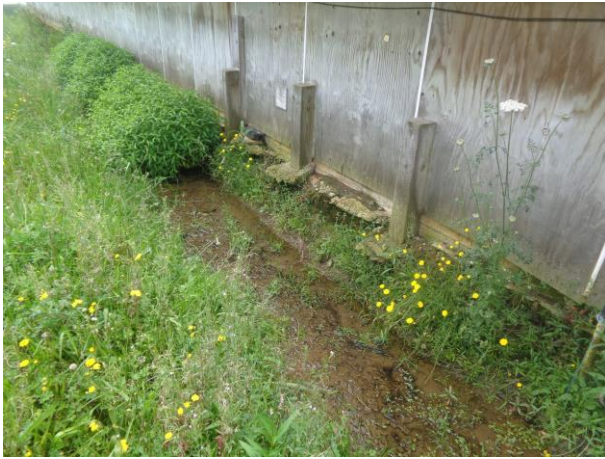
Drainage channel close to undermining slab

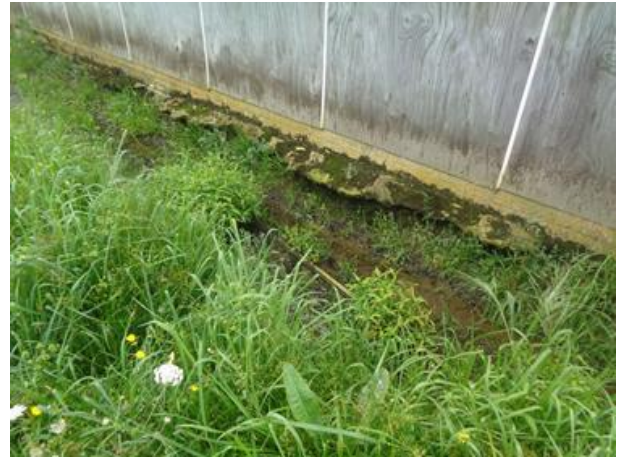
Drainage channel close to undermining slab

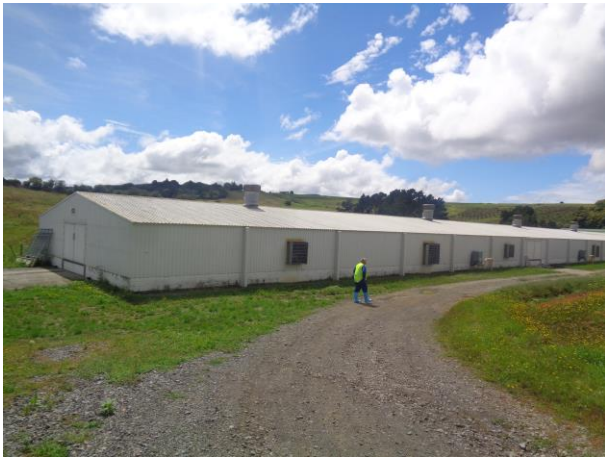
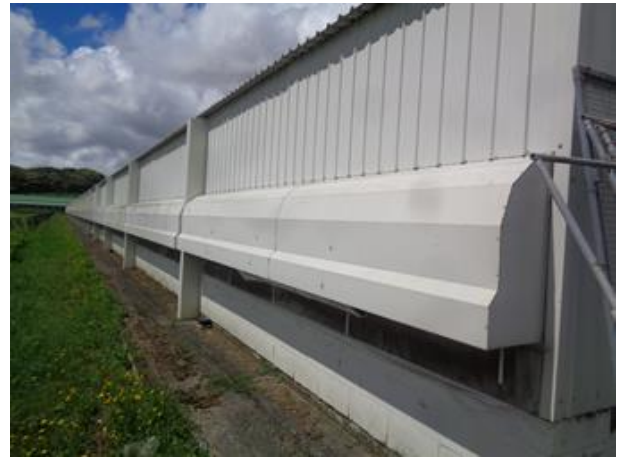
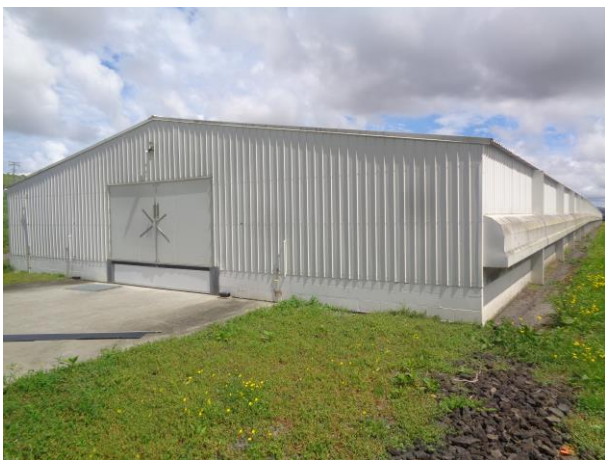
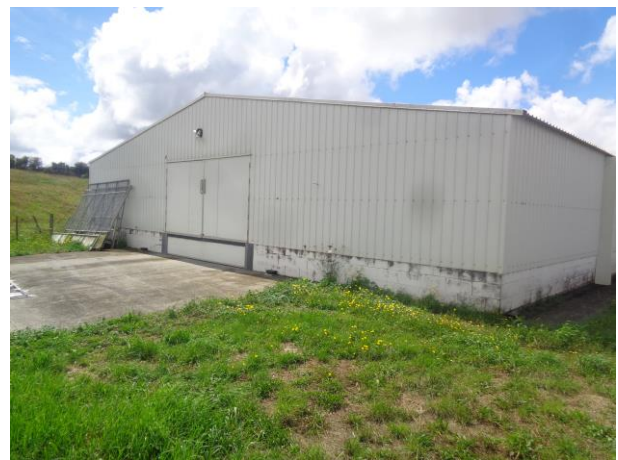
Shed F5 & F6

Typical exterior view

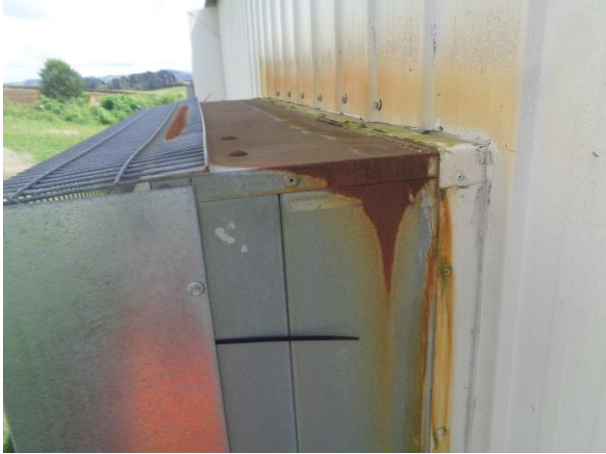
Rusting to top of louvre/fan housing

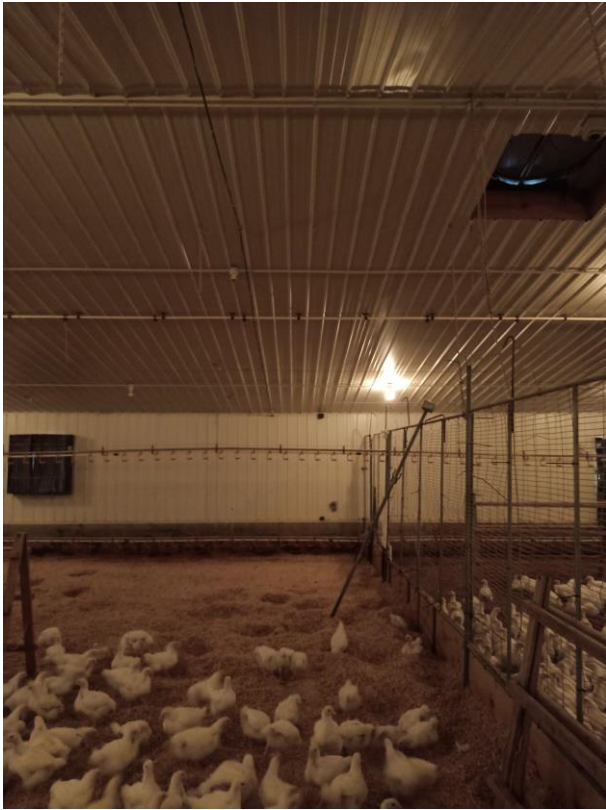
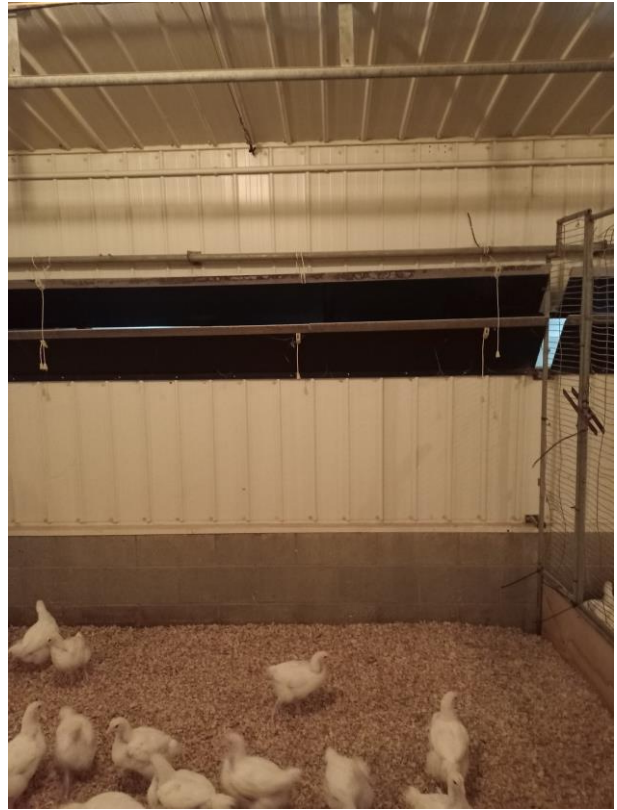
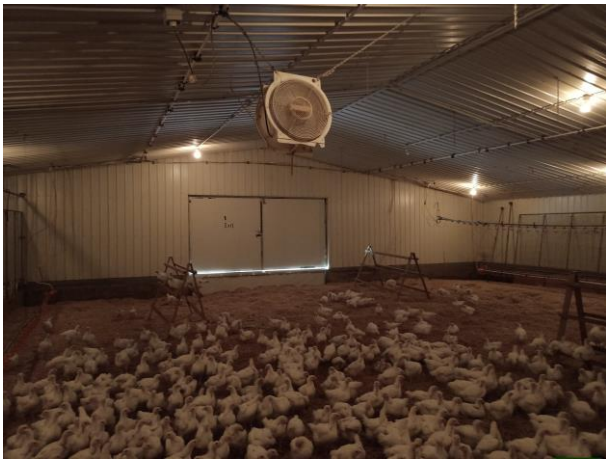
Roof has lichen and grime.

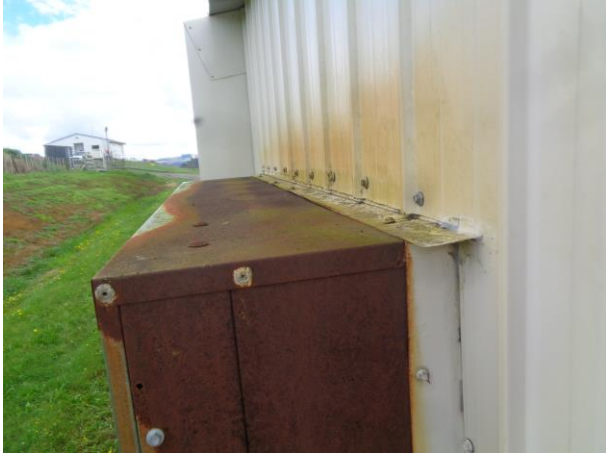
Rusting to top of louvre/fan housing

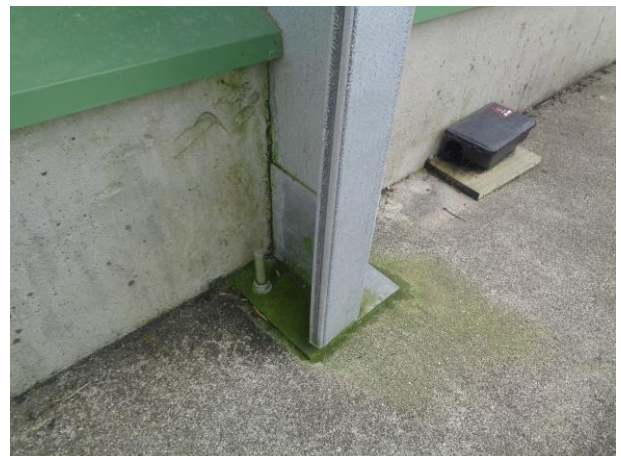
Base plate best on a concrete plinth

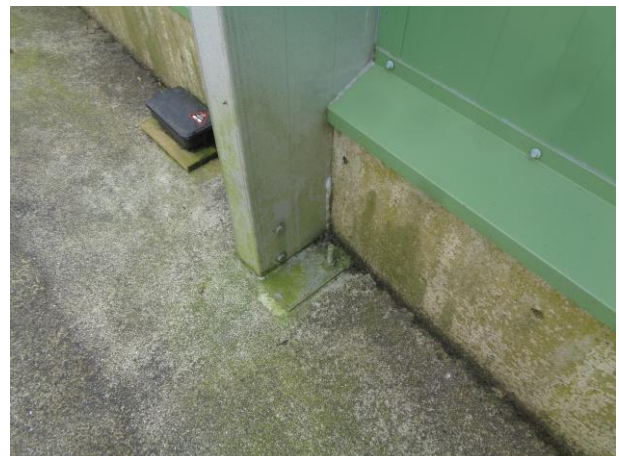
Base plate best on a concrete plinth

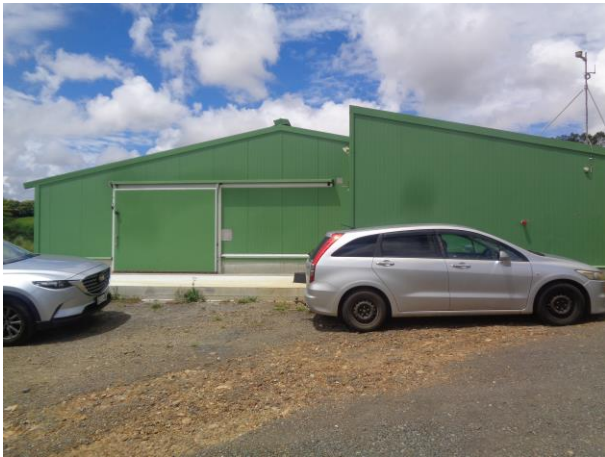
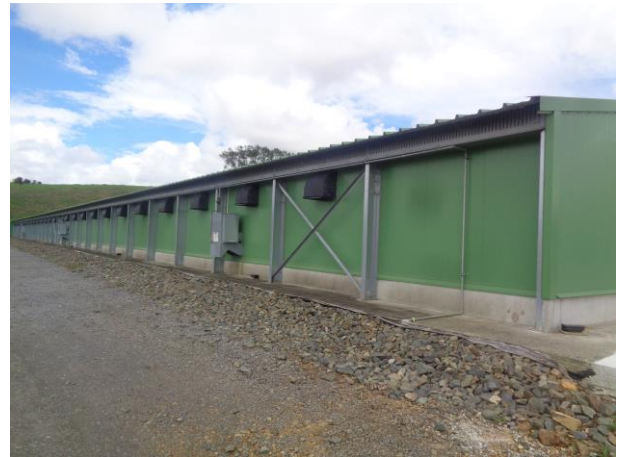
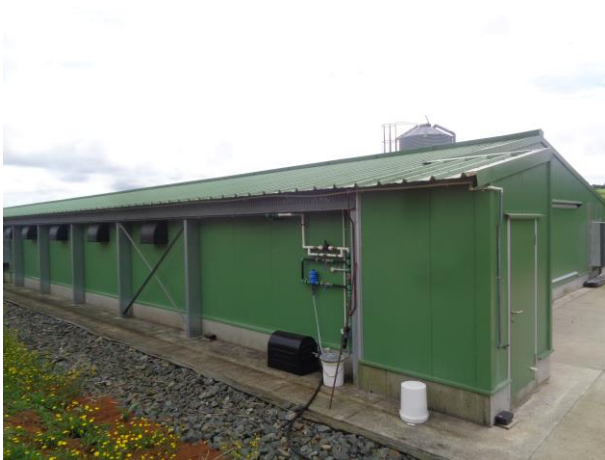
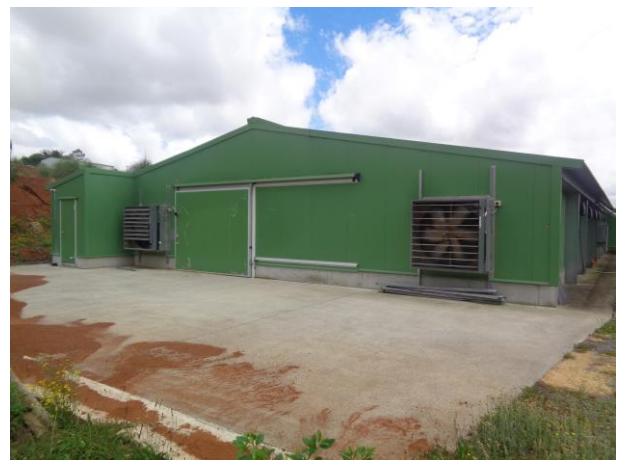
Shed F13

Typical exterior view

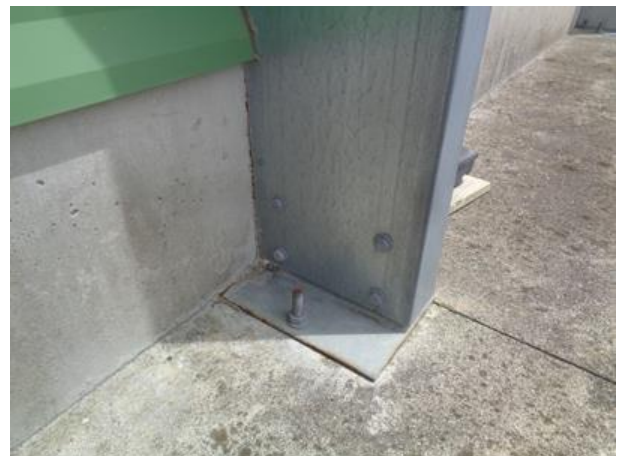
Base plate best on a concrete plinth

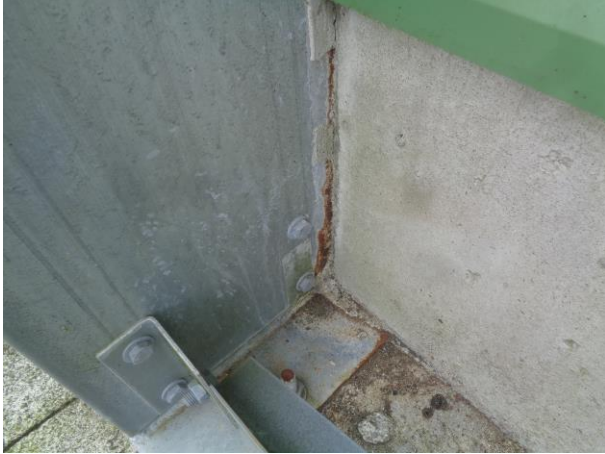
Rust developing at column concrete interface

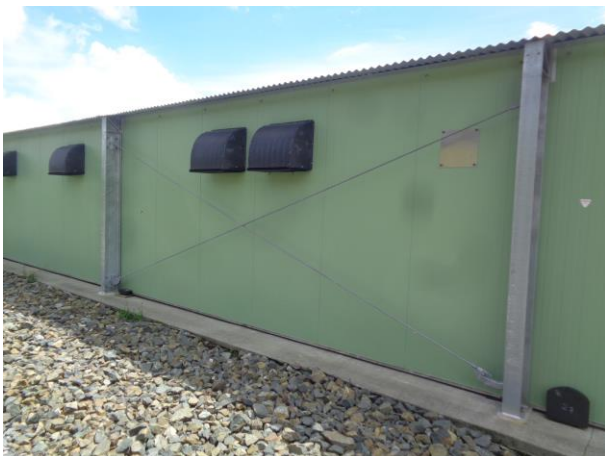
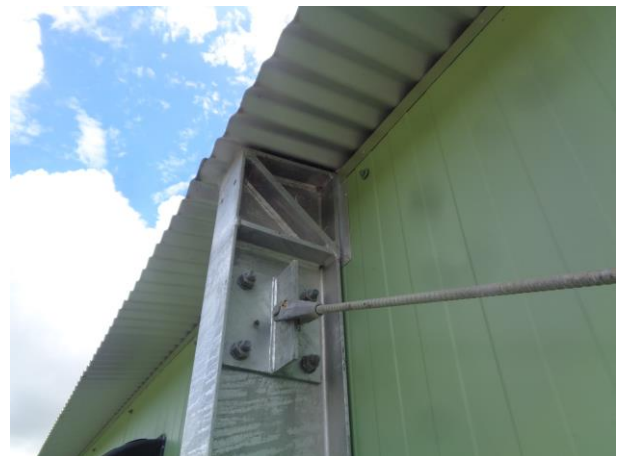
Insulated panel close to concrete slab and not located on a concrete nib.

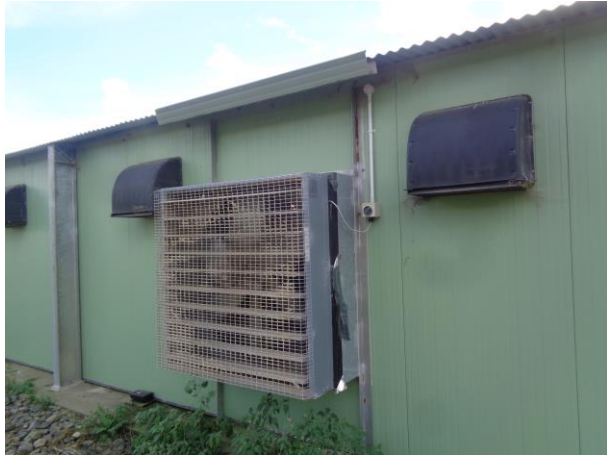
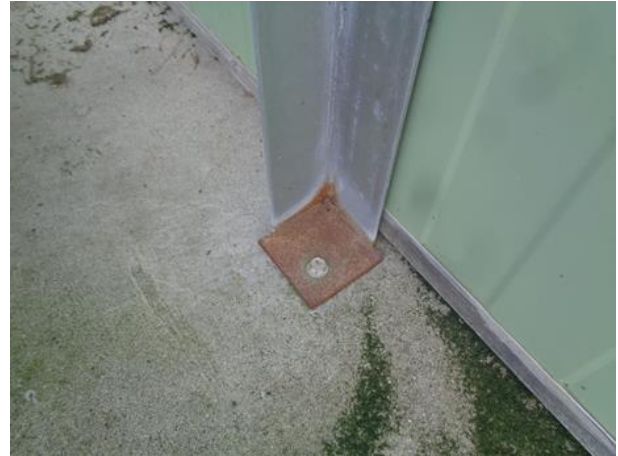
Intake ducts and extract louvres. Louvres to black intakes missing or damaged.

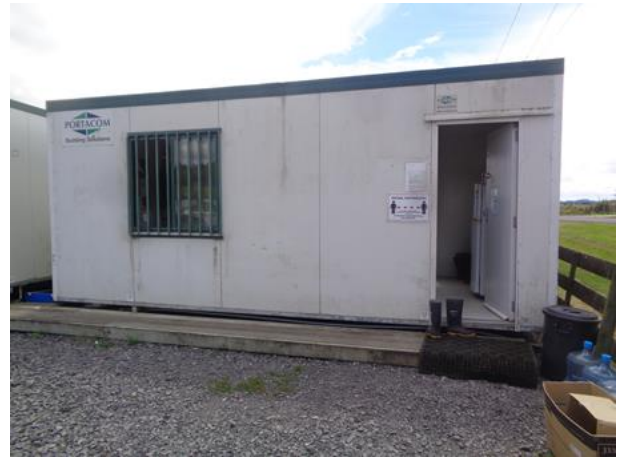
Grime to external walls

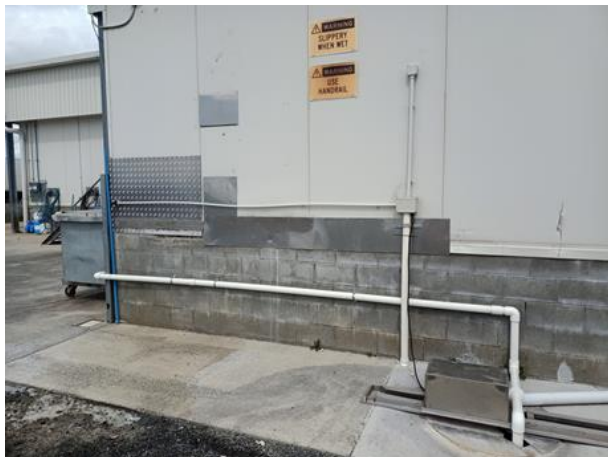
Sheet metal patches to damaged insulated panel

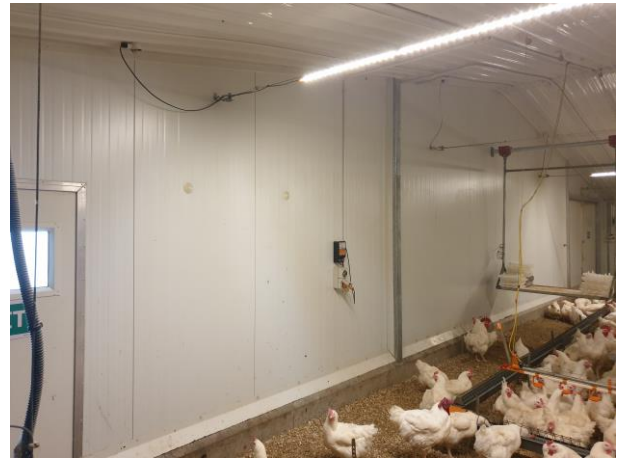
Typical interior construction – Shed 8

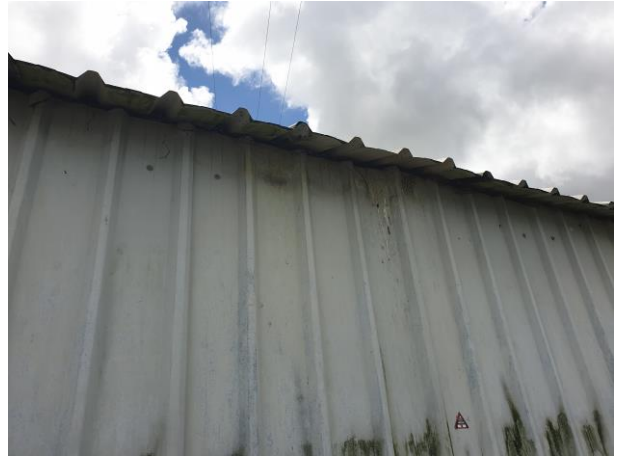
Typical exterior cladding weathering and lack of bird proofing at wall/roof junction

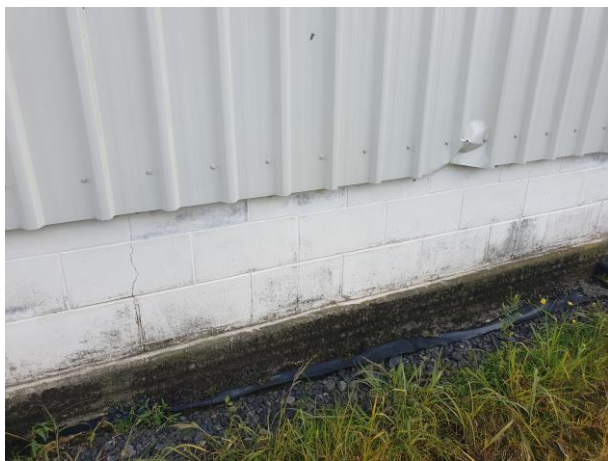
Typical perimeter upstand wall cracking and localised cladding damage

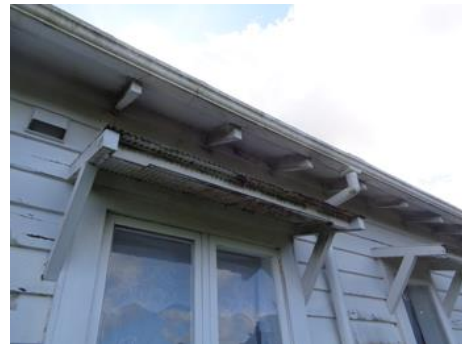
Grime, split weatherboards

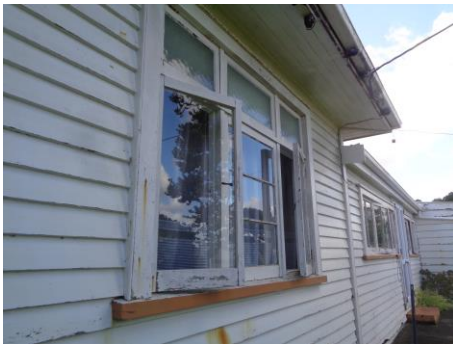
Timber window joinery poor condition

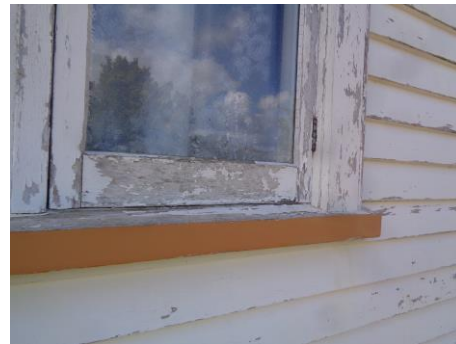
Timber window joinery poor condition

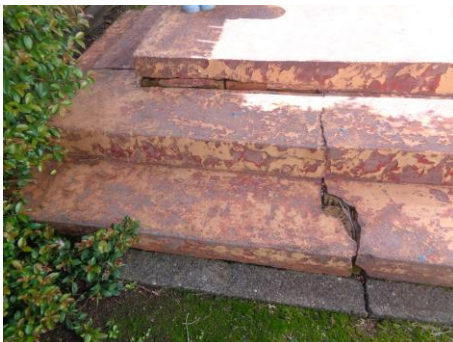
Crack to concrete patio

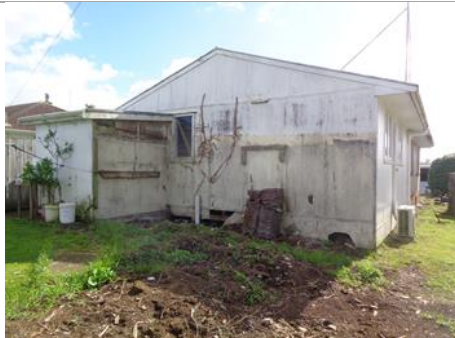
Sheet cladding in poor condition. Might be older James Hardies product containing asbestos.

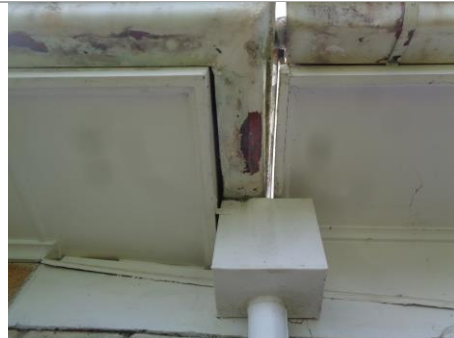
Odd junction between original building and addition at rear. Inspection required.

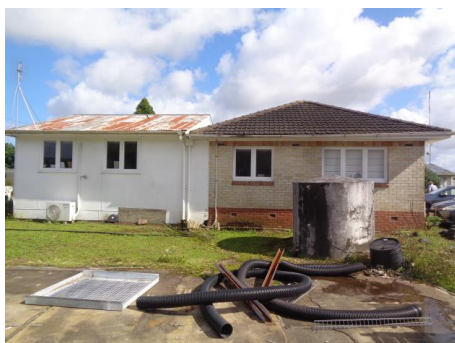
Iron roof and tile roof need attention.

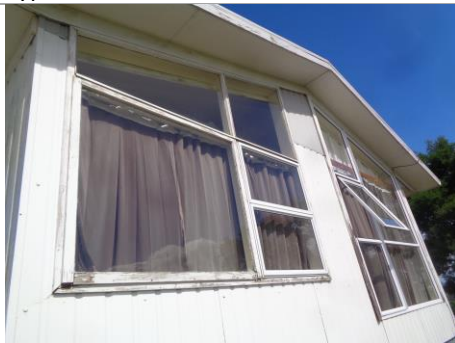
Timber facings to windows in poor condition

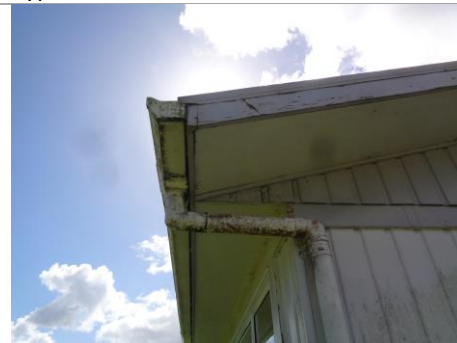
Grime to soffit, walls and gutter.

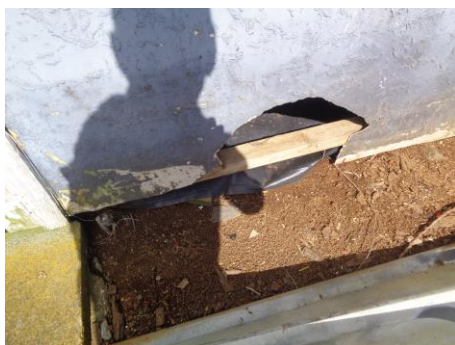
Subfloor cladding damage – possible older James Hardie product containing asbestos.

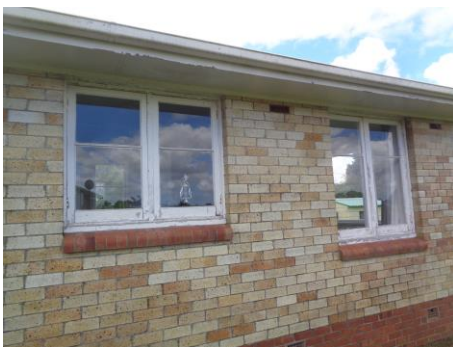
Timber windows poor condition

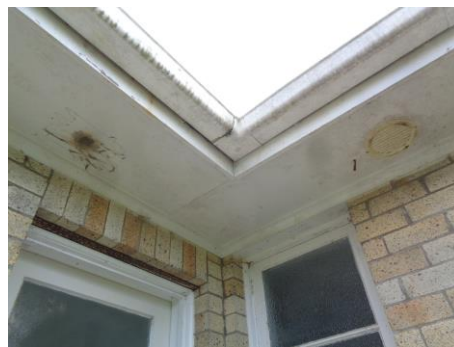
Grime to soffit and gutter

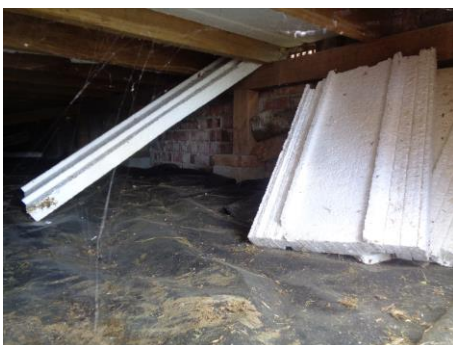
Subfloor insulation dislodged

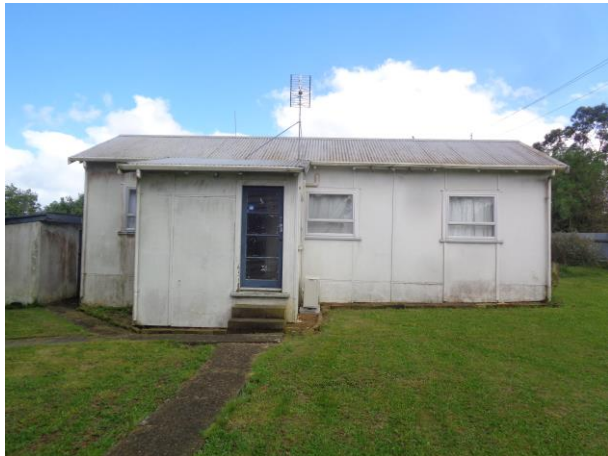
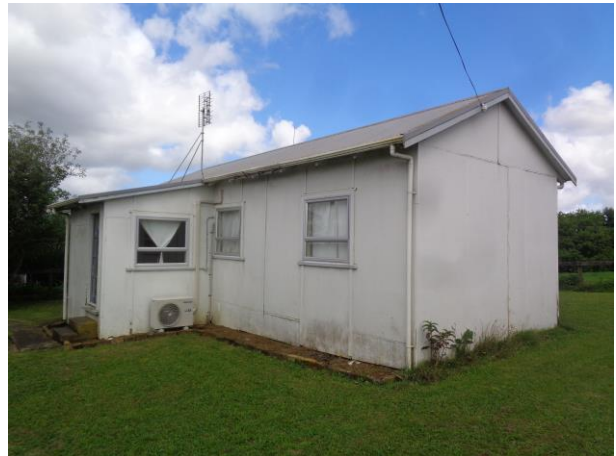
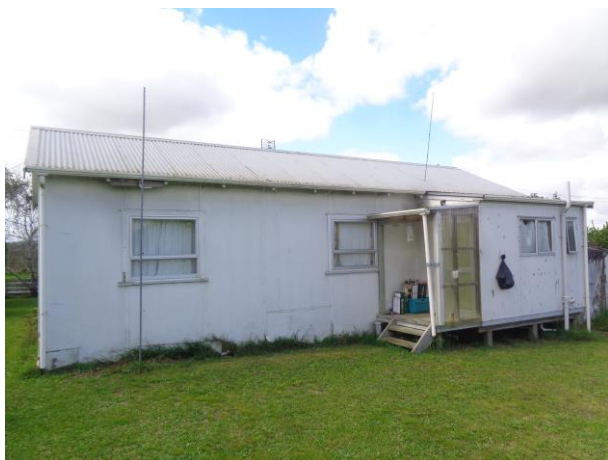
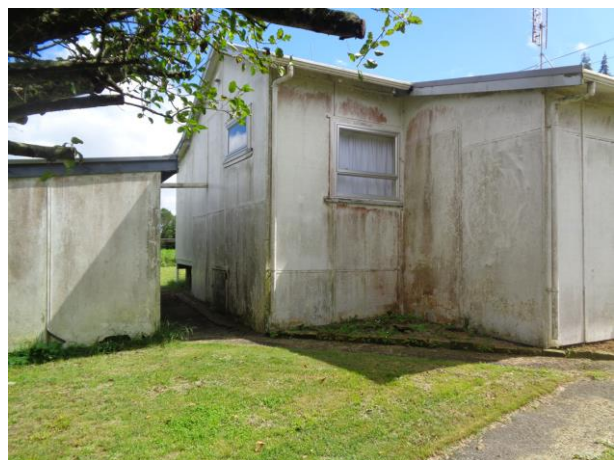
189 Roberts Road

Typical exterior view

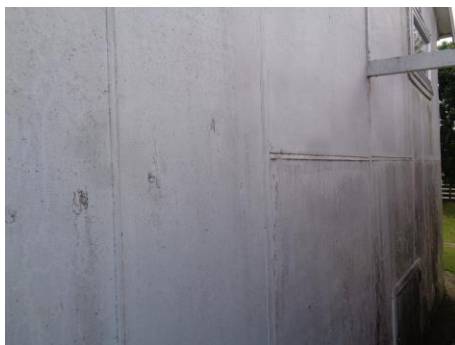
Grime to painted plywood cladding

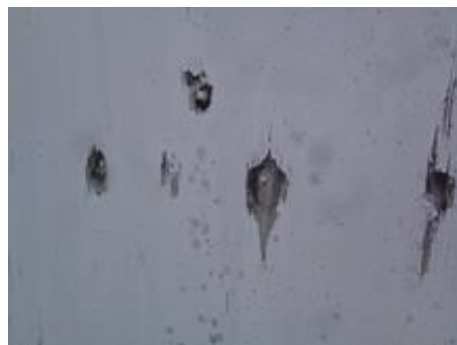
Exposed plywood.

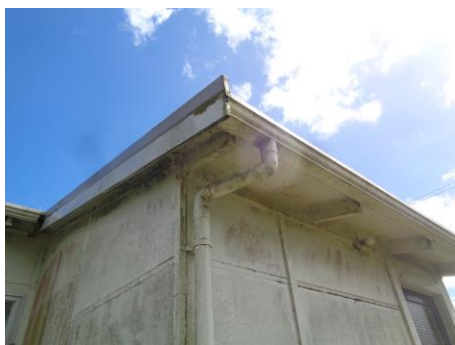
Grime to walls, soffits, downpipes.

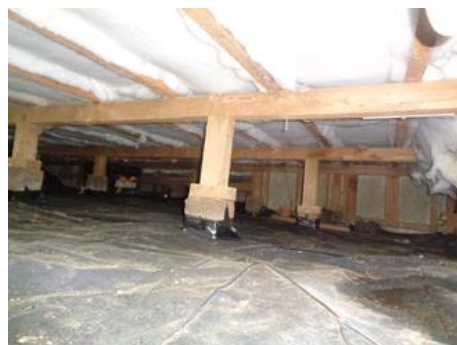
Subfloor insulation and pvc sheet.

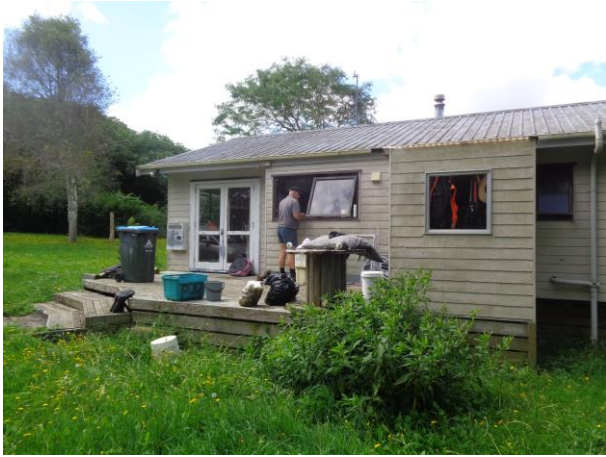
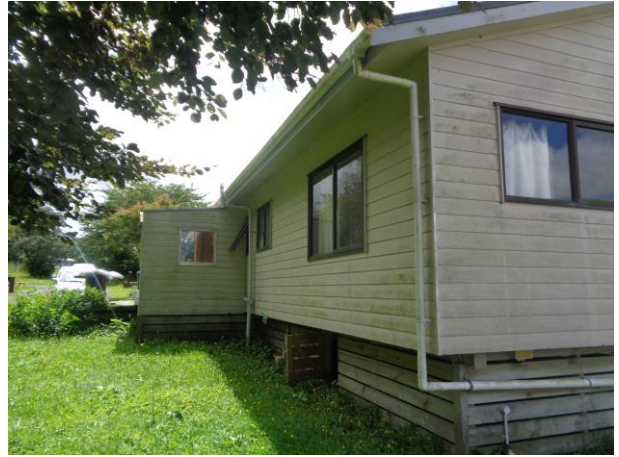
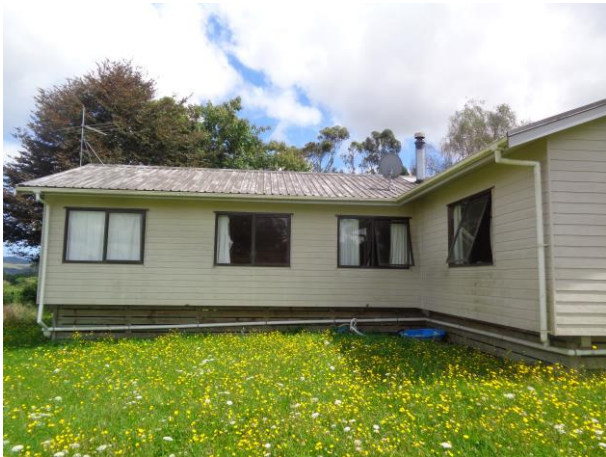
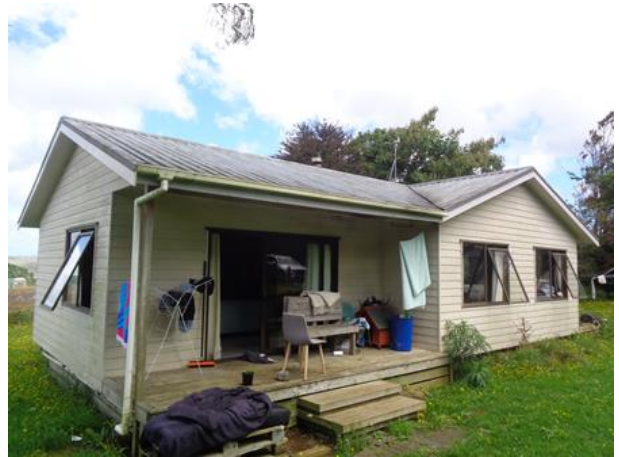
87 Andrews Road

Typical exterior view
